NORTH CAROLINA
Turnpike Authority

Maintenance Rating Program Triangle Expressway

2014 Second Quarter Ratings

Maintenance Rating Program for the Triangle Expressway

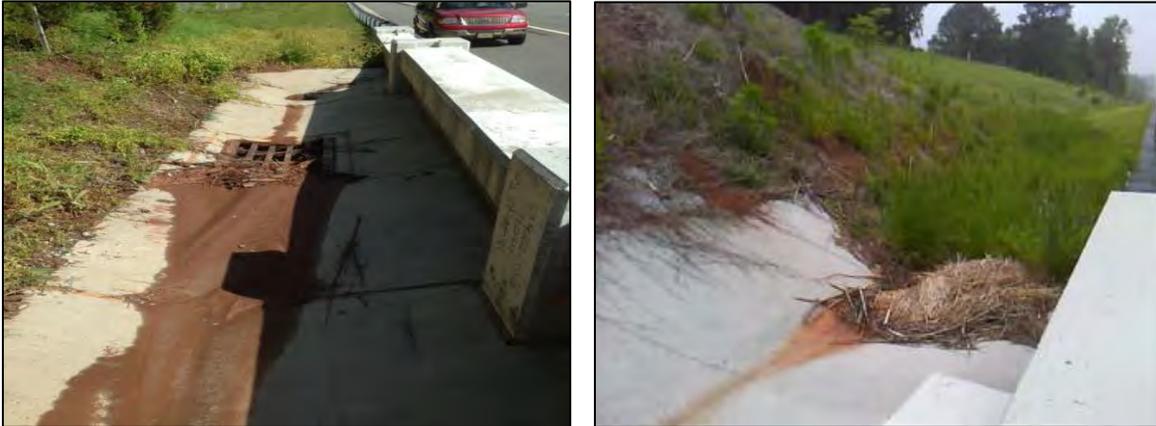
Figure 5: Paved Ditch Failures

Paved Ditches scored an overall MRP rating of 0 in our May survey. There are only two paved ditches on the Expressway and each are inspected during every quarter. During this inspection, both of them failed for material accumulation, and one for erosion. These can be seen in **Figure 5** below. There has been very heavy rain this spring and it is recommended that the maintenance provider complete a thorough sweep of the paved ditches on the project regularly to remove any debris that may have been washed down.

The maintenance provider should plan to remove any debris that may have been washed down onto the paved ditches due to the subsequent heavy rains on a consistent basis, and pavement markers should be checked and reapplied after the inclement weather season. The maintenance provider has demonstrated responsiveness to previous assessments and is expected to provide adequate corrective measures for both of these items. It should be noted that if both ditches did not contain debris and all of the markers had been reapplied after the winters inclement weather that the total second quarter score would be 91.4.

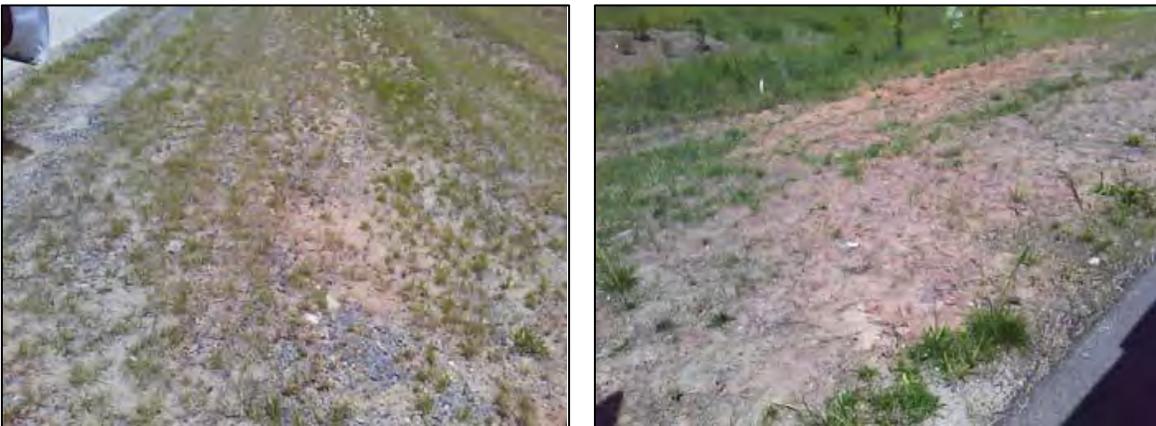
Figure 6: Turf Failures

Turf Condition did not score well in this survey (49), and there was a noticeable degradation in this second quarter assessment. Almost half of the areas surveyed failed due to bare ground, and several others failed due to undesirable vegetation. Some of these can be seen in **Figure 6** below. Many of the bare ground areas previously had active Bermuda and Centipede runners growing that are now dead. It is suspected this was caused by low cutting heights last summer during extreme heat months. With such a noticeable drop in the turf condition it is recommended that the maintenance provider schedule overseeding of these areas with warm season grasses and possibly add soil enrichment to increase the chances of survival. It is further suggested that mowing heights be closely monitored especially during the months of extreme heat conditions.

Turf Condition is failing for both the second quarter and for the cumulative rolling score, and needs the most attention. It is recommended that over seeding of these areas occur with warm season turf seed such as Bermuda grass, and that the cycles of mowing and trimming are maintained with special attention toward preventing scalping the turf from low cutting heights.

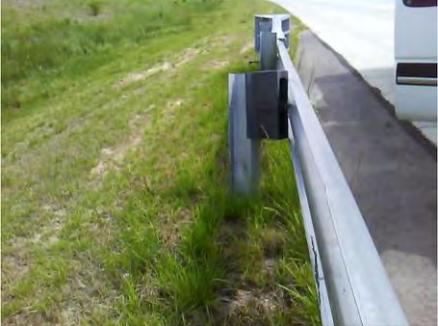
#	Material Type	Object ID	Failure Type	Photo	GIS Reference Page
1	Guardrail	BR_35	Missing Parts

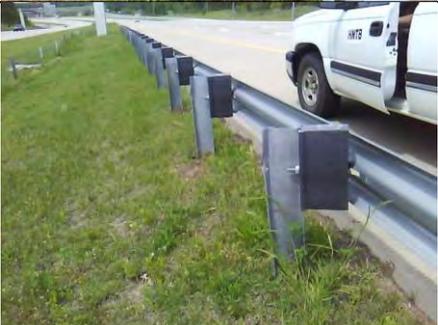
A23
2	Guardrail	BR_245	Functional Damage

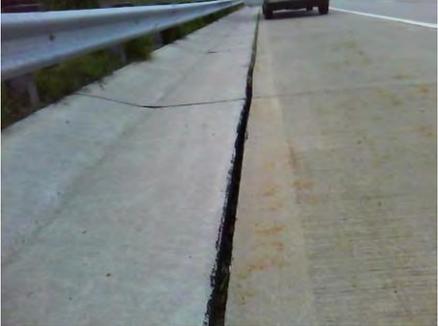
#	Material Type	Object ID	Failure Type	Photo	GIS Reference Page
1	Valley	CG_163	Misalignment

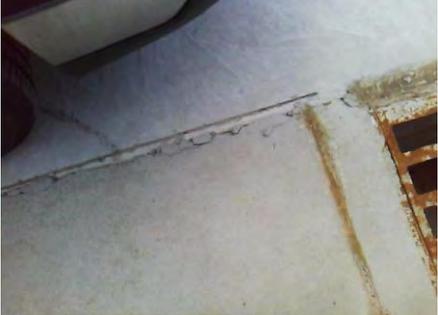
A2, A3
2	Valley	CG_222	Structural Damage

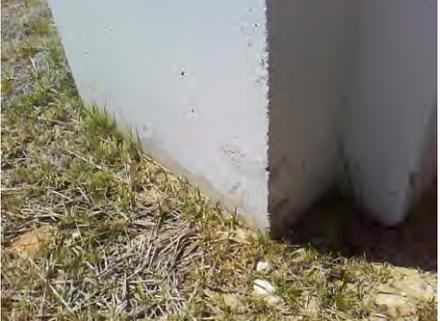
#	Material Type	Object ID	Failure Type	Photo	GIS Reference Page
1	Overhead Sign Support	DS_236	Scaling

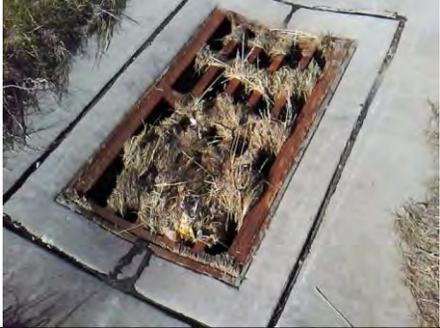
#	Material Type	Object ID	Failure Type	Photo	GIS Reference Page
1	Cross Pipe	DP_425	Obstruction

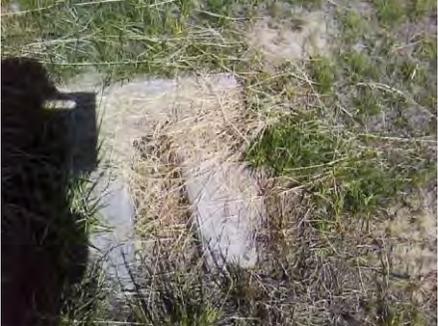
#	Material Type	Object ID	Failure Type	Photo	GIS Reference Page
1	Shoulder Drain	MDP_28	Obstruction

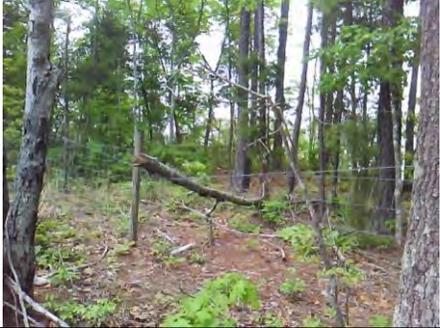
#	Material Type	Object ID	Failure Type	Photo	GIS Reference Page
1	Woven	FN_160	Tree on Fence

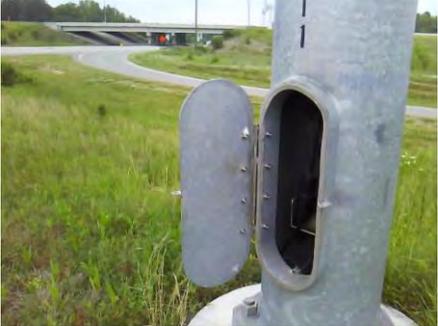
#	Material Type	Object ID	Failure Type	Photo	GIS Reference Page
1	High Mast	HL_118	Part Damage

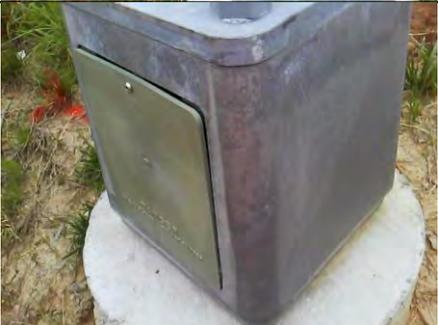
A9
2	Underpass Lighting	HL_277	Part Damage

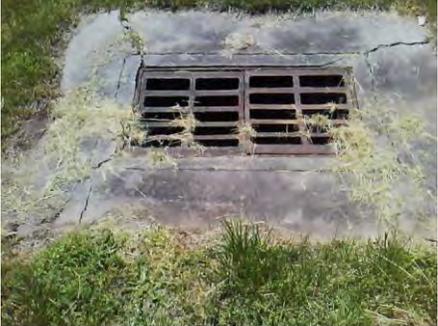
#	Material Type	Object ID	Failure Type	Photo	GIS Reference Page
1	Inlet	IN_179	Surface Damage

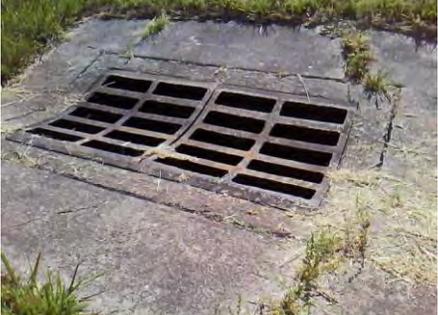
A48, A49
2	Inlet	IN_184	Surface Damage

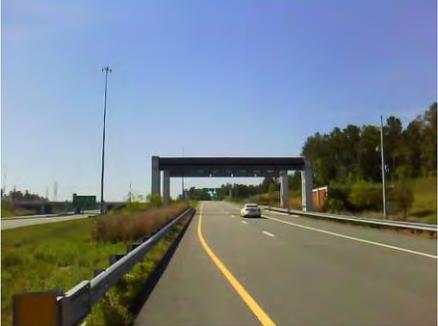
#	Material Type	Object ID	Failure Type	Photo	GIS Reference Page
1	Plant Bed	PB_34	Unhealthy

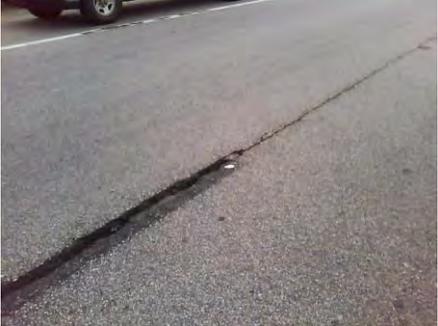
#	Material Type	Object ID	Failure Type	Photo	GIS Reference Page
1	Asphalt	LS_8	Cracking

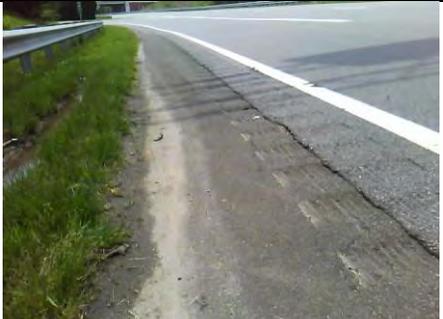
#	Material Type	Object ID	Failure Type	Photo	GIS Reference Page
1	Asphalt	LS_245	Paved Shoulder Joint

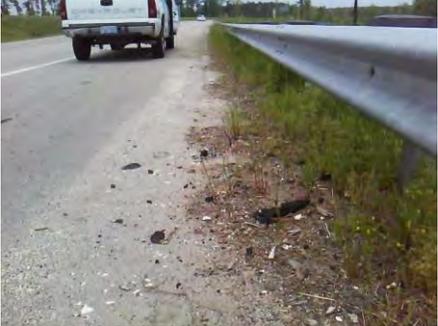
#	Material Type	Object ID	Failure Type	Photo	GIS Reference Page
1	Unpaved Shoulder	LS_8	Buildup

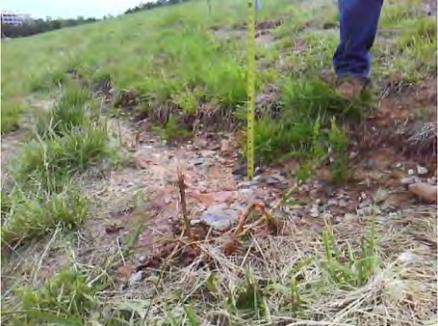
#	Material Type	Object ID	Failure Type	Photo	GIS Reference Page
5	Unpaved Shoulder	LS_314	Elevation Deviation

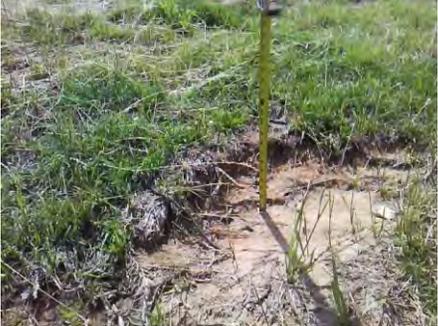
#	Material Type	Object ID	Failure Type	Photo	GIS Reference Page
1	Slope	LS_29	Slope Failure

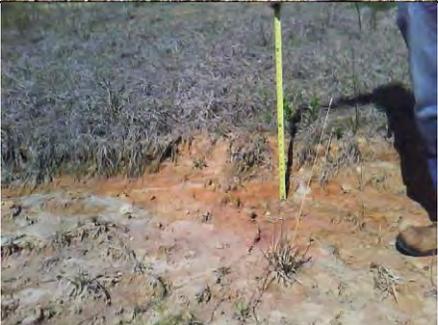
A26, A28, A29
2	Slope	LS_179	Slope Failure

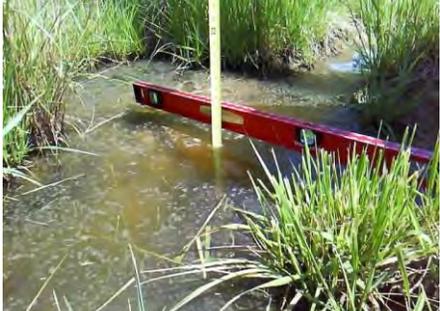
#	Material Type	Object ID	Failure Type	Photo	GIS Reference Page
1	Outfall Ditch	LS_431	Erosion

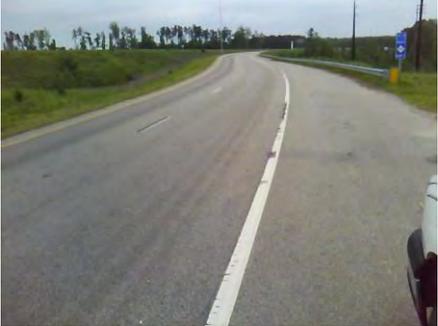
#	Material Type	Object ID	Failure Type	Photo	GIS Reference Page
1	Asphalt	LS_8	Line Width

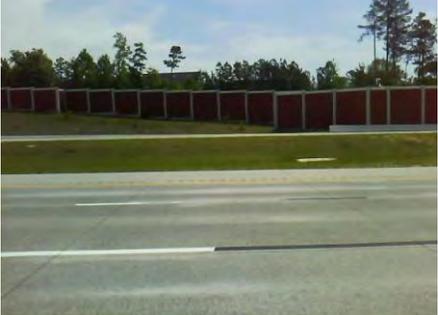
A9
2	Concrete	LS_411	Line Width

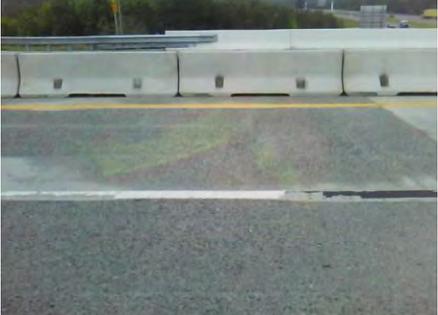
A32, A33
3	Concrete	LS_599	Line Missing

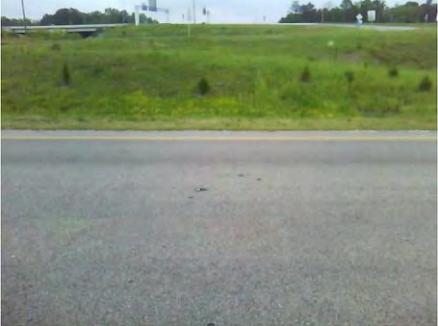
#	Material Type	Object ID	Failure Type	Photo	GIS Reference Page
1	Asphalt	LS_8	Missing Markers

removed the non-snowplowable markers from bridge decks. It is recommended that the maintenance provider consider replacing markers as soon as practical at the end of each winter season.

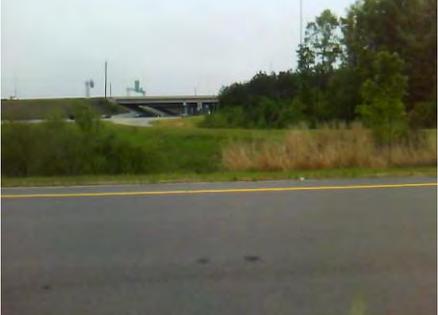
A9
2	Asphalt	LS_177	Missing Markers

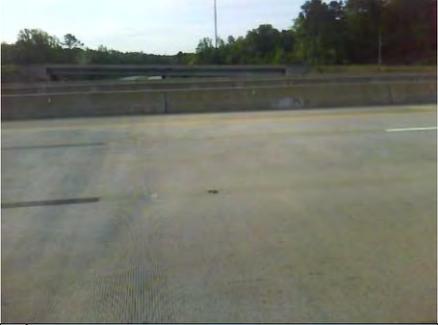
A9, A10
3	Concrete	LS_326	Missing Markers

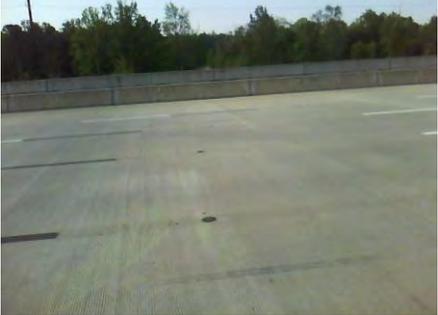
A5, A6
4	Concrete	LS_335	Missing Markers

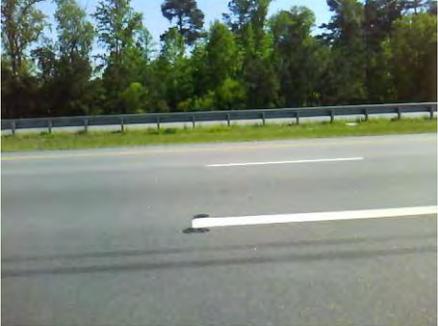
#	Material Type	Object ID	Failure Type	Photo	GIS Reference Page
5	Asphalt	LS_395	Missing Markers

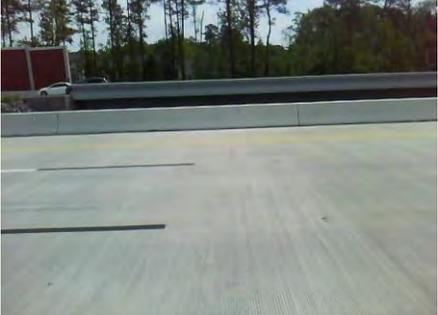
A29, A30
6	Concrete	LS_411	Missing Markers

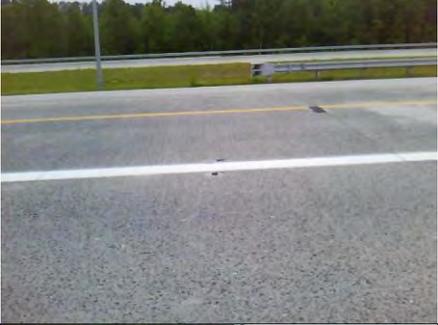
A32, A33
7	Concrete	LS_494	Missing Markers

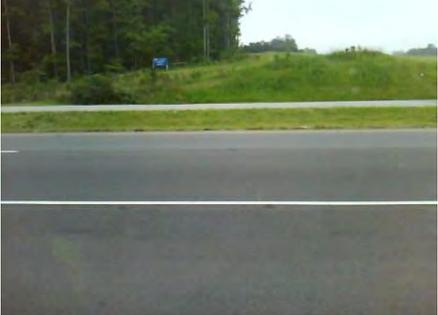
A45, A46
8	Asphalt	LS_544	Missing Markers

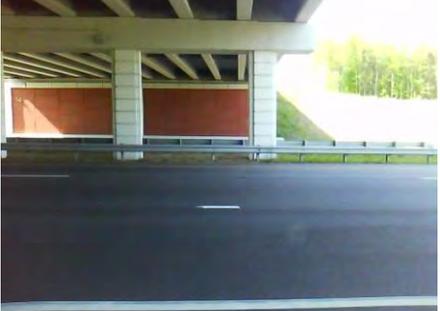
#	Material Type	Object ID	Failure Type	Photo	GIS Reference Page
9	Asphalt	LS_594	Missing Markers

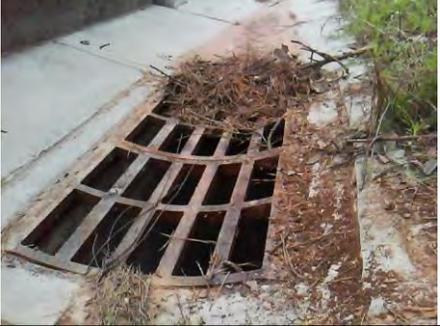
#	Material Type	Object ID	Failure Type	Photo	GIS Reference Page
1	Paved Ditch	PD_11	Material Accumulation

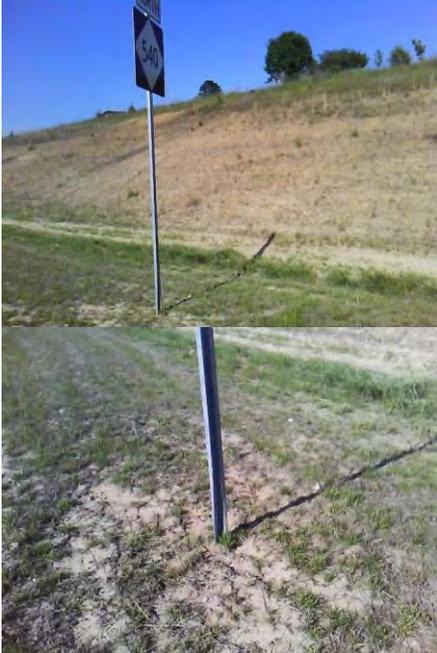
#	Material Type	Object ID	Failure Type	Photo	GIS Reference Page
1	NC Route	SN_66	Nighttime Failure, Rotation and Sign Support

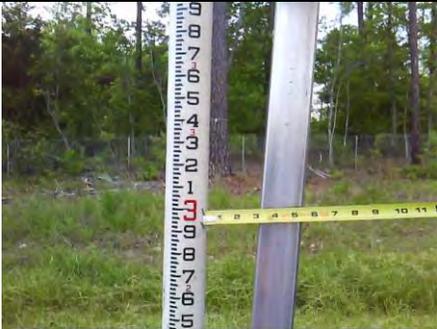
A25
2	Toll Payments	SN_163	Nighttime Failure	Not Available for Nighttime Failure.	A18
3	Wrong Way	SN_369	Leaning

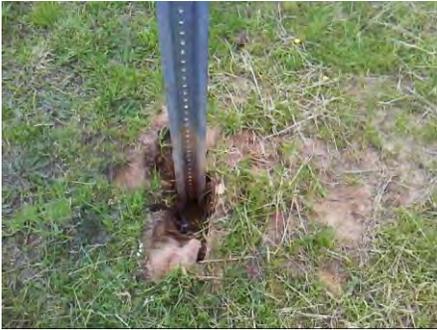
#	Material Type	Object ID	Failure Type	Photo	GIS Reference Page
4 (Cont.)	NC Route	SN_498	Leaning and Sign Support

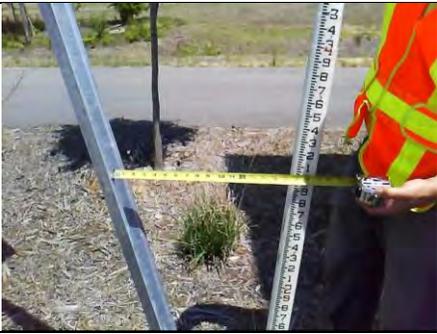
A2
5	Toll Rates	SN_578	Nighttime failure	Not Available for Nighttime Failure.	A45
6	Authorized Vehicles	SN_793	Leaning

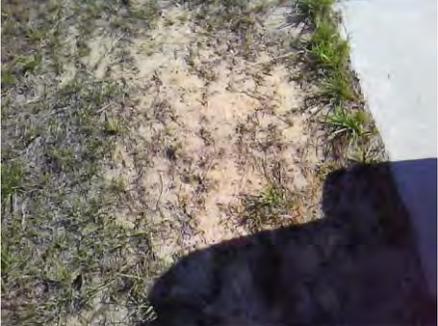
#	Material Type	Object ID	Failure Type	Photo	GIS Reference Page
1	Turf	TF_25	Bareground

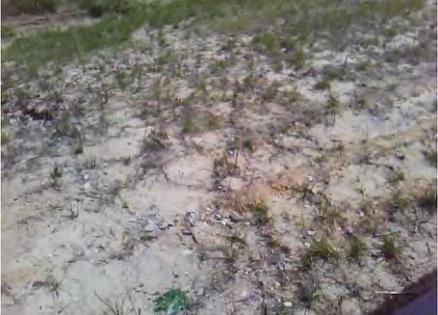
A20
4	Turf	TF_65	Bareground

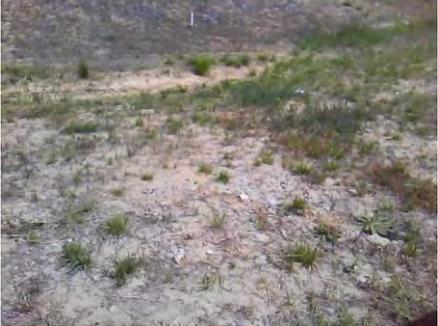
#	Material Type	Object ID	Failure Type	Photo	GIS Reference Page
5	Turf	TF_68	Bareground

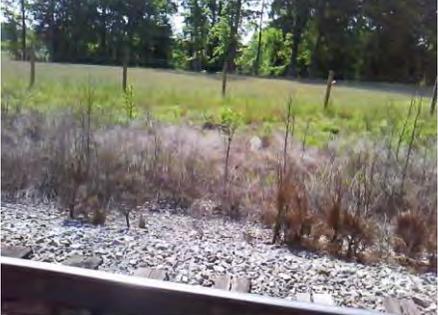
A27, A28, A31
8	Turf	TF_129	Undesirable vegetation

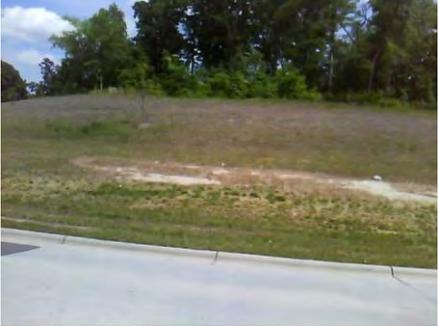
#	Material Type	Object ID	Failure Type	Photo	GIS Reference Page
9	Turf	TF_179	Bareground

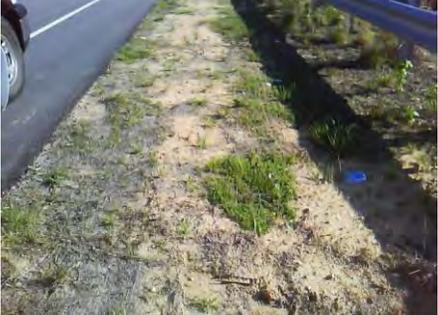
A26, A28, A29
12	Turf	TF_222	Bareground

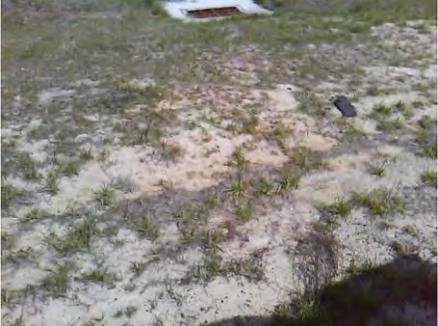
#	Material Type	Object ID	Failure Type	Photo	GIS Reference Page
13	Turf	TF_236	Bareground

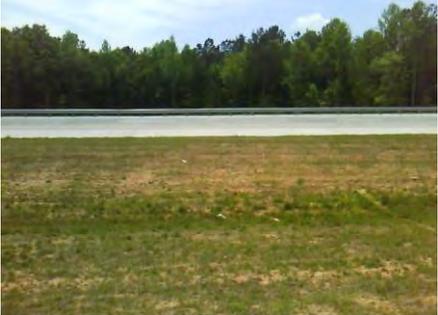
A45
16	Turf	TF_312	Bareground

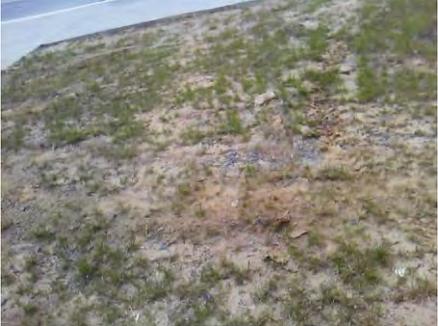
#	Material Type	Object ID	Failure Type	Photo	GIS Reference Page
17	Turf	TF_355	Bareground

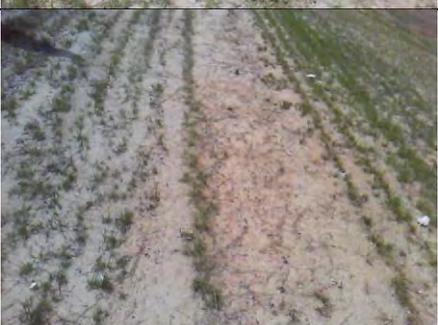
A46, A47
20	Turf	TF_469	Bareground

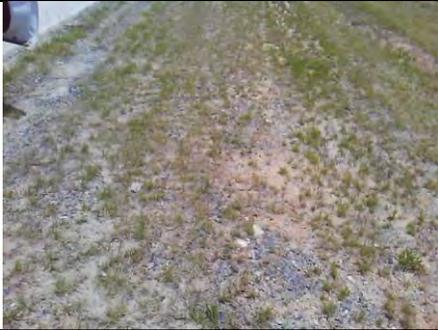
#	Material Type	Object ID	Failure Type	Photo	GIS Reference Page
21	Turf	TF_471	Bareground

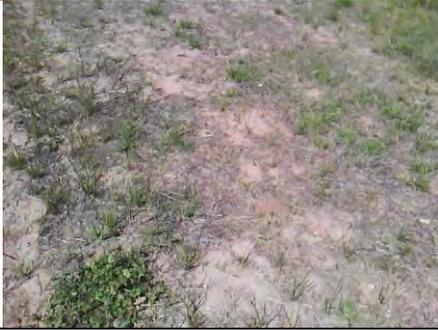
A32, A33
24	Turf	TF_816	Bareground

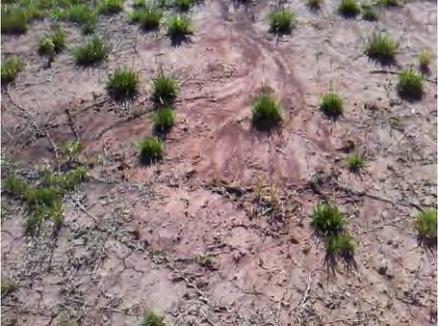
#	Material Type	Object ID	Failure Type	Photo	GIS Reference Page
25	Turf	TF_852	Bareground

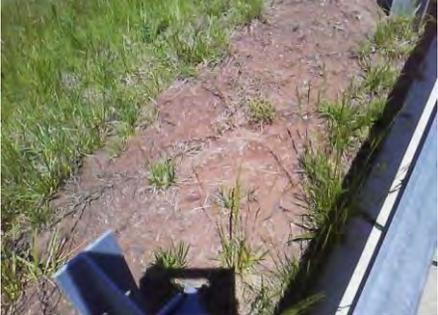
A54
28	Turf	TF_888	Bareground

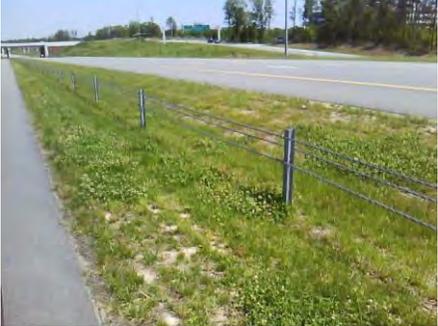
#	Material Type	Object ID	Failure Type	Photo	GIS Reference Page
29	Turf	TF_898	Noxious Weeds

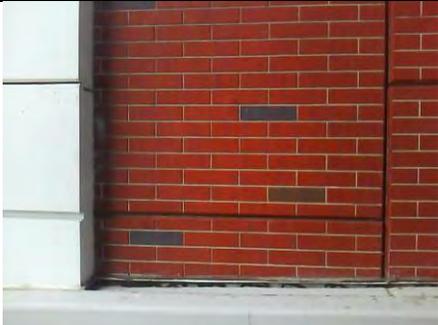
#	Material Type	Object ID	Failure Type	Photo	GIS Reference Page
1	Bridge Wall	WL_63	Cracked joint

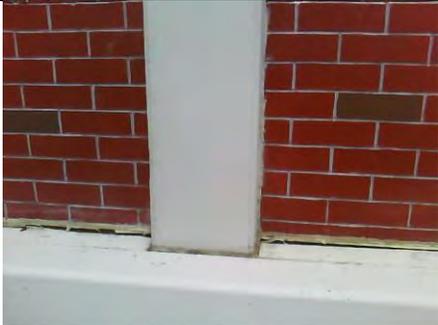
A39, A40
2	Sound Wall	WL_96	Cracked joint

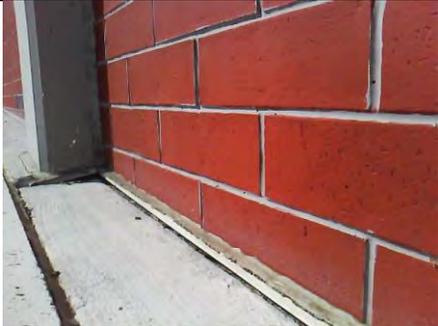
A33, A34
3	Sound Wall	WL_101	Cracked joint
