NORTH CAROLINA
Turnpike Authority

Maintenance Rating Program

Triangle Expressway

2015 Third Quarter Report

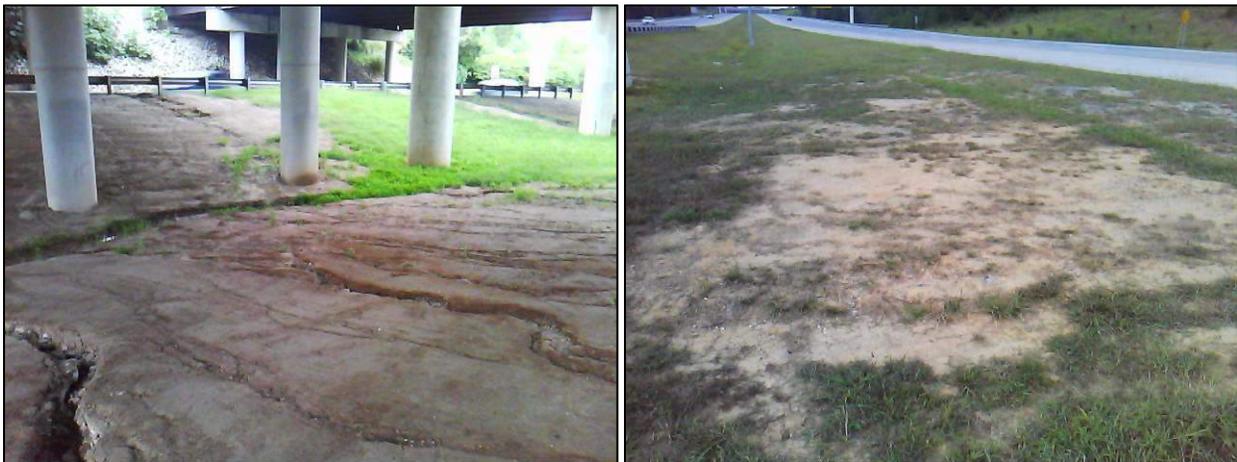
Figure 3: Turf Failures

Turf Condition (47 rating – 39 of the 74 assets failed). Out of the 74 turf areas inspected, 39 failed due to bare ground. Two of the failing turf areas can be seen in the **Figure 3**.

As per the NCDOT Division 5 Landscape Unit Plan presented during the second quarter, the hydro-seeding process of a selected bare ground area with warm season grasses began during the third quarter. Also, all turf areas along the facility were fertilized. As of this report, no positive results from these efforts have been observed and ratings continue to drop. However, it is important to recognize that results from these efforts may not be immediate as it may take several years for the turf to be fully established.

The NCDOT Division 5 Landscape Unit continues to monitor turf bare ground areas and is working closely with the Roadside Environmental staff to determine an effective treatment for these areas. The unit is also planning two more fertilization treatments during May and August of 2016. Future MRP assessments will continue to track the progress of the program and its effectiveness.

Turf Condition is continuing to fail for both the quarterly and the cumulative rolling ratings, and needs the most attention. It is recommended that soil nourishment through a routine fertilizing campaign and selective hydro-seeding of bare ground areas with warm season grasses continue throughout the summer of 2016.

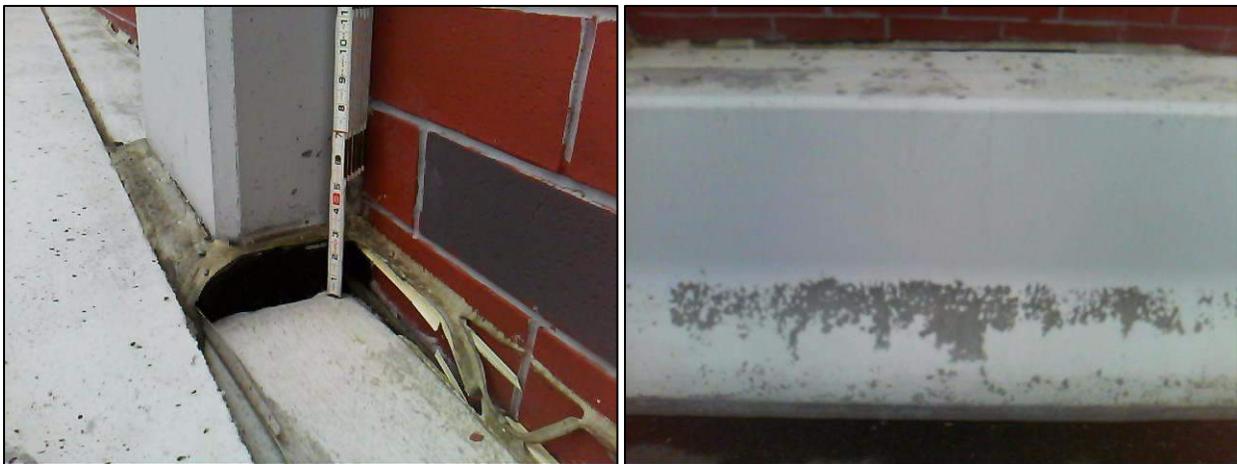
Figure 4: Retaining, Sound and Screen Wall Failures

Retaining, Sound and Screen Walls (79 rating – 4 of the 19 assets failed). Wall failures were related to paint scaling and joint separation. Two of the failing walls are presented in *Figure 4*.

The joint failures are likely caused by settlement of backfill material (usually wash stone) below the cap plate, and between the sound wall and the concrete barrier wall. These repairs should fall within the warranty of workmanship clause from the original construction. Otherwise, it is recommended that repairs take place by removing the cap and replacing backfill material compacted in 6 inch layers.

In order to avoid further deterioration of these walls, it is recommended that the maintenance provider paint all wall sections experiencing paint scaling, especially those sections painted white.

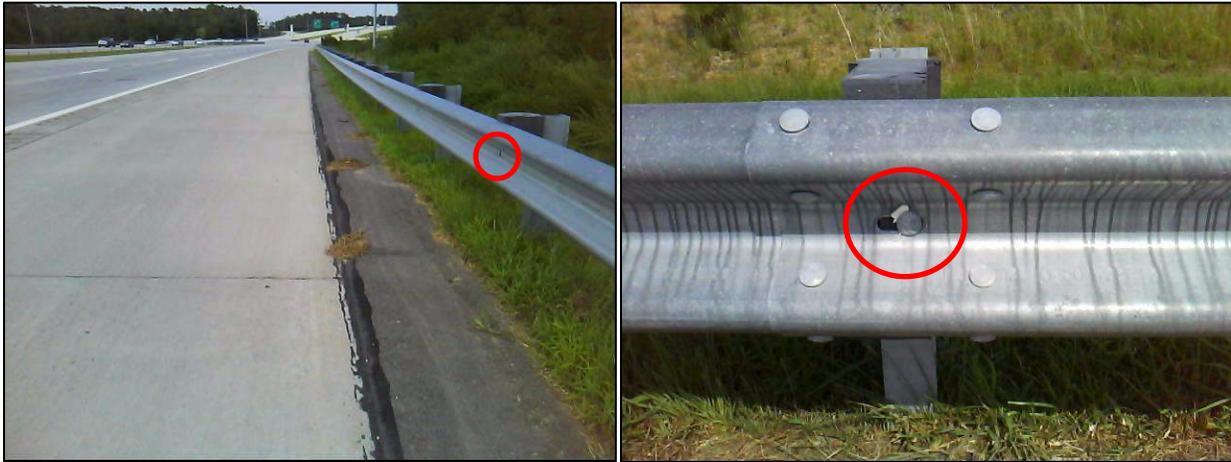
Figure 5: Delineator Failures

Delineators (76 rating – 11 of the 45 assets failed). Of the 11 linear segments that failed due to delineators, 10 failed because of missing delineators and 1 failed due to lack of reflectivity. Two of the failing linear segments due to delineators are presented in *Figure 5*.

It is thought that the automated mowing equipment utilized to trim underneath guardrails may be damaging or removing guardrail delineators. Therefore, it is recommended that guardrail delineators be replaced and that mowing activities be closely monitored to avoid the removal or damage of delineators.

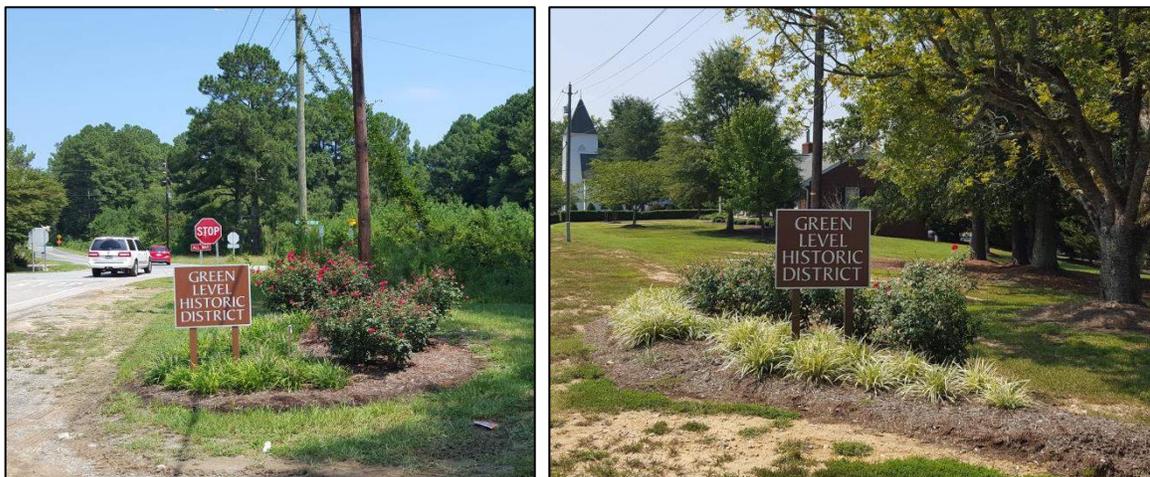
Figure 6: Green Level West Historic District Signs

As part of each quarterly inspection, assessors visit the four Green Level Historic District signs to conduct a visual inspection of each sign to ensure they are in good standing. During this quarterly inspection, all signs were found to be in good condition, with the landscaped areas being well maintained. **Figure 6** shows two of these signs.

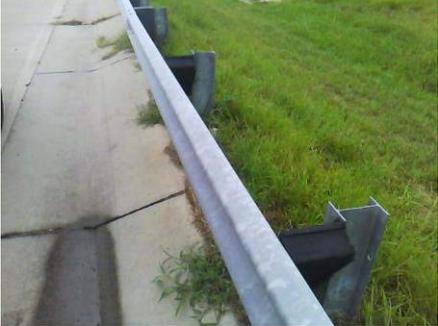
#	Material Type	Object ID	Failure Type	Photo	GIS Reference Page
1	Guardrail	BR_316	Twisted Block

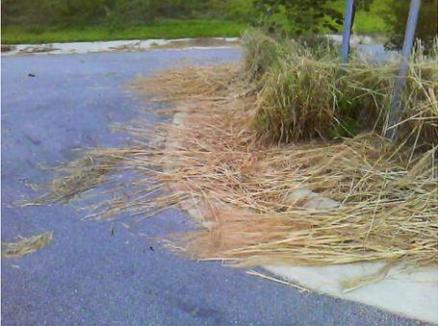
#	Material Type	Object ID	Failure Type	Photo	GIS Reference Page
1	Valley	CG_128	Obstruction

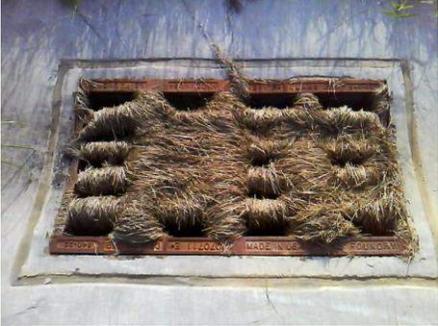
#	Material Type	Object ID	Failure Type	Photo	GIS Reference Page
1	Drain	DP_12	Obstruction

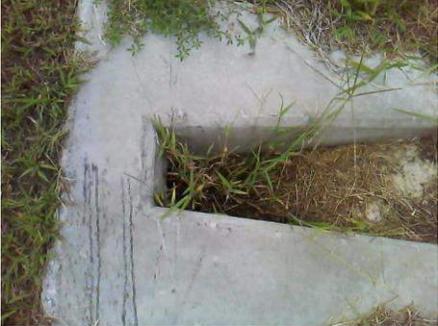
#	Material Type	Object ID	Failure Type	Photo	GIS Reference Page
1	Shoulder Drain	MDP_59	Obstruction

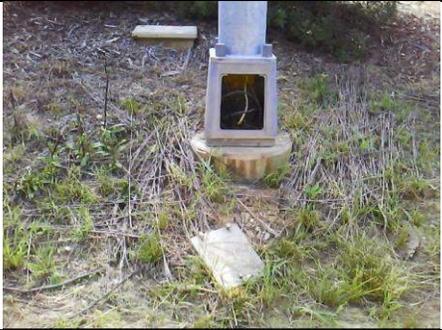
#	Material Type	Object ID	Failure Type	Photo	GIS Reference Page
1	Single Roadway	HL_15	Functional Damage and Missing Parts

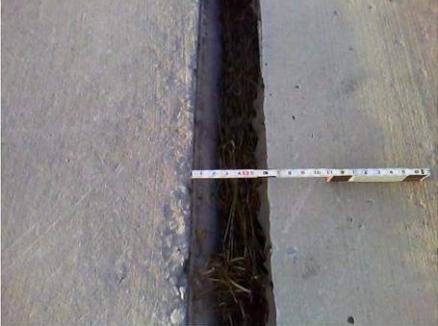
#	Material Type	Object ID	Failure Type	Photo	GIS Reference Page
1	Concrete	LS_112	Paved Shoulder Joint

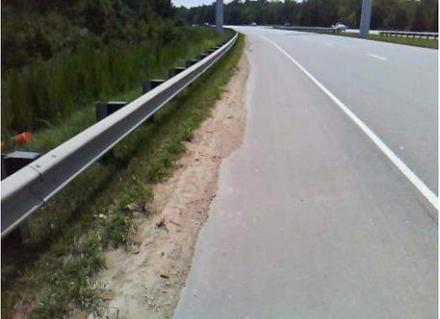
#	Material Type	Object ID	Failure Type	Photo	GIS Reference Page
1	Asphalt	LS_386	Roadway Sweeping

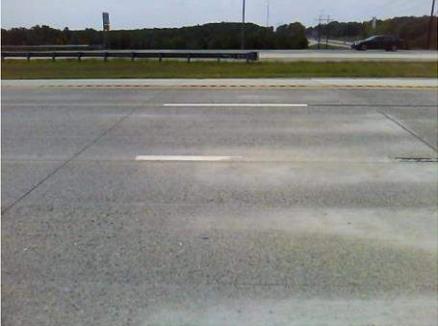
#	Material Type	Object ID	Failure Type	Photo	GIS Reference Page
1	Concrete	LS_463	Line Missing

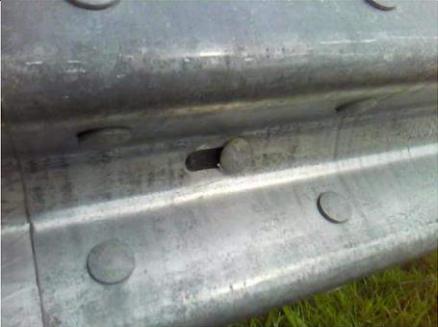
#	Material Type	Object ID	Failure Type	Photo	GIS Reference Page
1	Concrete	LS_38	Nighttime Reflectivity and Missing Parts

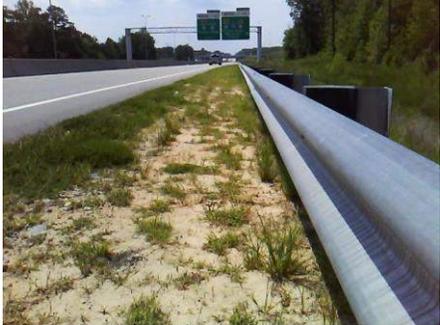
#	Material Type	Object ID	Failure Type	Photo	GIS Reference Page
5	Asphalt	LS_379	Nighttime Reflectivity and Missing Parts

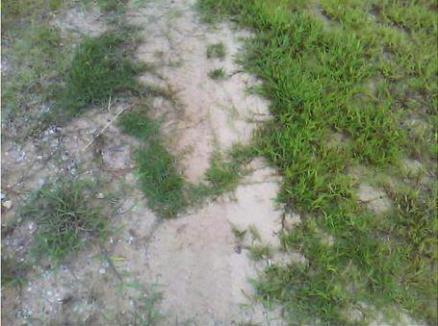
#	Material Type	Object ID	Failure Type	Photo	GIS Reference Page
1	Turf	TF_45	Bareground

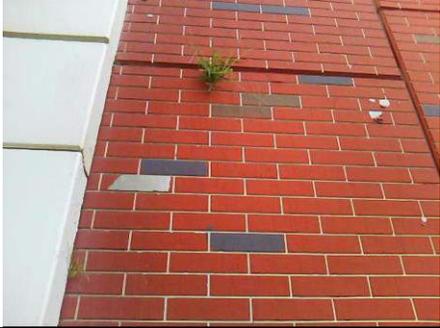
#	Material Type	Object ID	Failure Type	Photo	GIS Reference Page
1	Sound Wall	WL_36	Paint Scaling
