NORTH CAROLINA
Turnpike Authority

Maintenance Rating Program

Triangle Expressway

2015 First Quarter Report

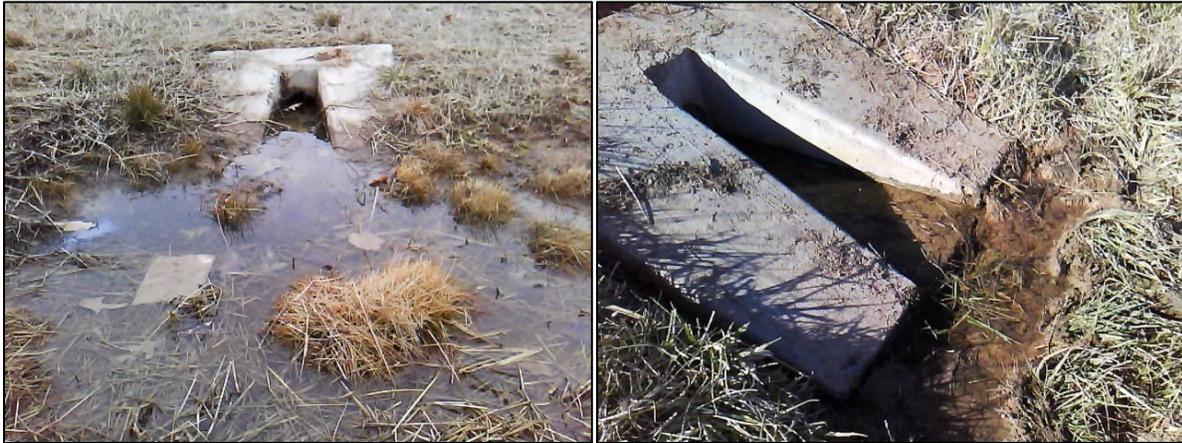
Figure 3: Miscellaneous Drainage Failures

Miscellaneous Drainage Structures (75 rating – 8 of the 32 assets failed). All 8 miscellaneous drainage structures failed because of obstruction (**Figure 3**). Out of the 8 obstruction failures, 1 occurred because of debris blocking the outlet and 7 occurred due to standing water from ditch line backing up into the outlet. In order to prevent these failures from occurring, it is recommended for the maintenance provider to routinely clean out ditches near these drainage features to allow for the continuous flow of water, as well as remove any vegetation or debris that has washed into or grown up around the structure.

In order to improve this quarter's substandard scores, it is recommended that the maintenance provider continue to plan to remove any ditch debris on a consistent basis. Also, pavement markers should be checked and reapplied after the seasons of inclement weather.

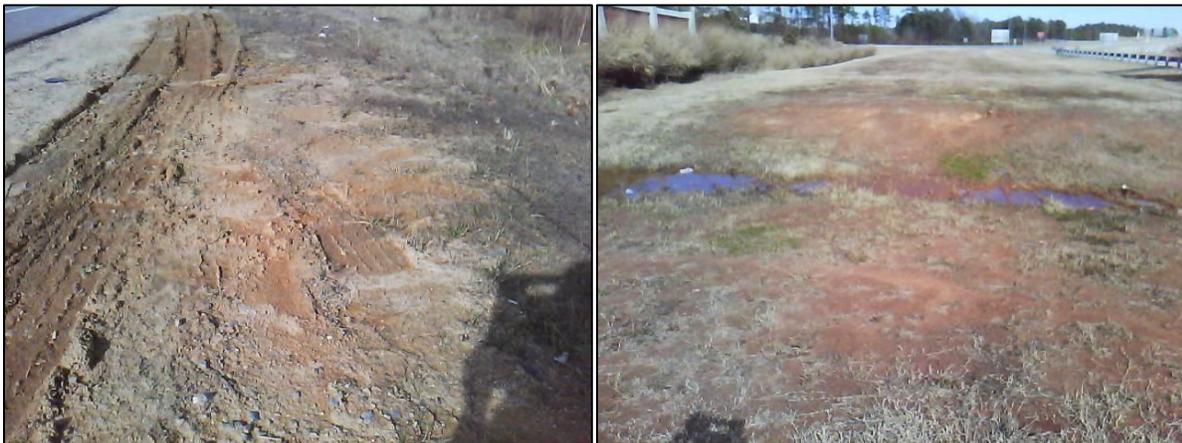
Figure 4: Turf Failures

Turf Condition (54 rating – 34 of the 74 assets failed). All 34 turf areas failed because of bare ground. Two of the failing turf areas can be seen in **Figure 4**. Many of the bare ground areas previously had active Bermuda and Centipede runners growing that are now dead. It is suspected this condition was originally caused by low cutting heights during the summer of 2013. With such a noticeable drop over the last few assessments in the turf condition and no noticeable improvement in scores, it is recommended that the maintenance provider schedule overseeding of these areas with warm season grasses and possibly add soil enrichment to increase the chances of survival. It is further suggested that mowing heights continue to be closely monitored especially during the months of extreme heat conditions.

Turf Condition is continuing to fail for both the quarterly and the cumulative rolling score, and needs the most attention. It is recommended that over seeding of these areas occur with warm season turf seed, such as Bermuda grass, and that the cycles of mowing and trimming are maintained with special attention toward preventing low cutting heights.

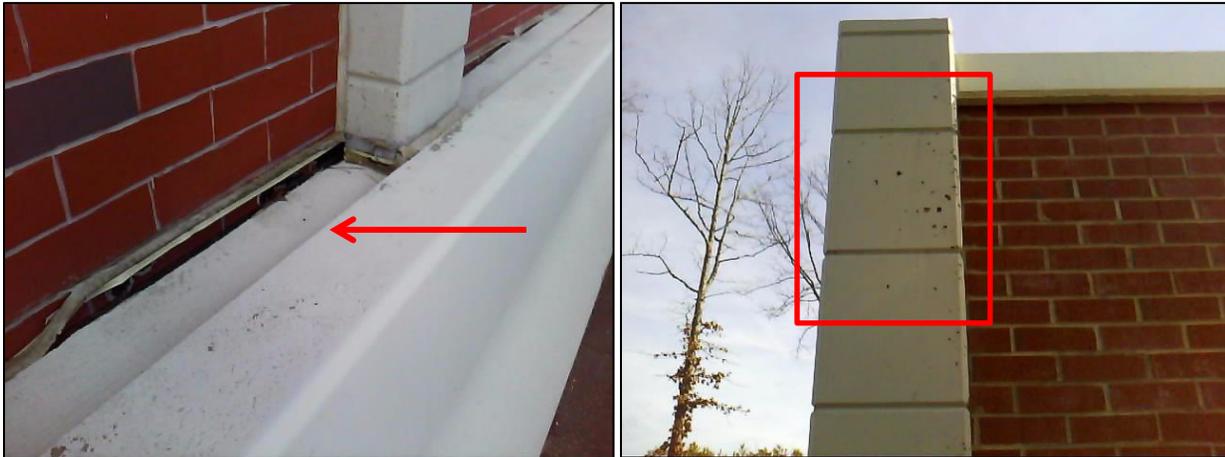
Figure 5: MSE/Retaining Walls, Sound Barrier Walls and Screen Walls Failures

MSE/Retaining Walls, Sound Barrier Walls and Screen Walls (79 rating – 4 of the 19 assets failed). The retaining wall and sound wall failures were related to spalls and joint separation. Two of these failures can be seen in *Figure 5*. In order to avoid further deterioration of these walls, it is recommended that the maintenance provider seal all spalls and joints immediately. It is also recommended that all joint failures be closely monitored as these failures could be related to foundation settlement or slope instability, which would impact the integrity of the structure.

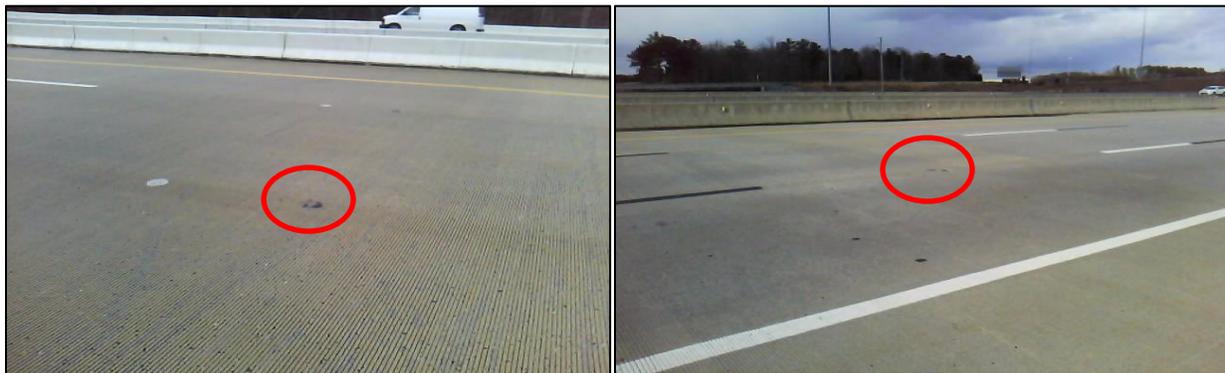
Figure 6: Pavement Markers Failures

Pavement Markers (64 rating – 21 of the 59 assets failed). All 21 pavement marker failures are due to missing markers and insufficient reflectivity during nighttime inspections (*Figure 6*).

During the past several years the Triangle Expressway has seen several rounds of frozen precipitation where plows have removed the non-snowplowable markers from bridge decks. It is recommended that the maintenance provider consider replacing bridge deck markers as soon as practical at the end of each winter season and prior to the upcoming season, at a minimum. Additionally, it should be noted that pavement markers have an average life of 3 years when reflectivity begins to diminish below acceptable levels. The northern section of the Triangle Expressway (Toll NC 147) was opened in December of 2011 and replacement of the existing markers should be scheduled this year.

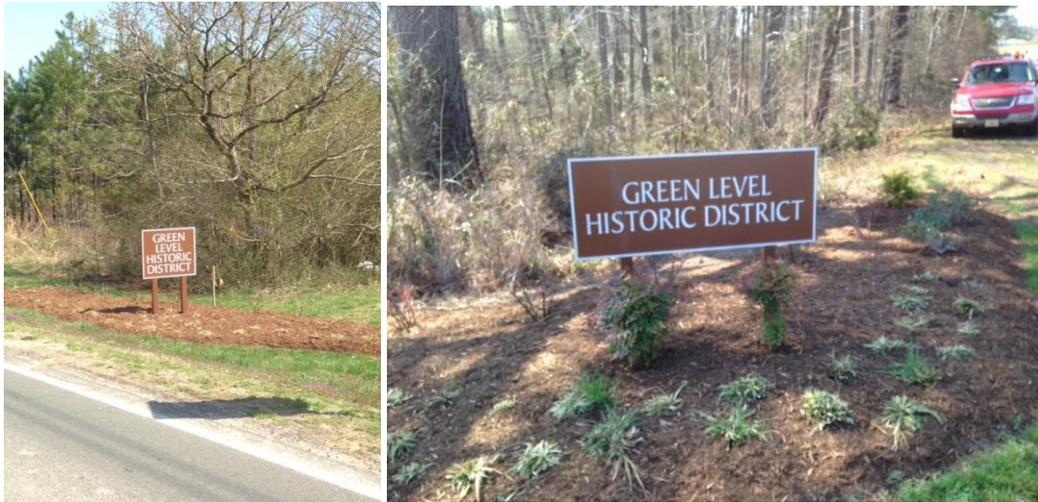
Figure 7: Green Level West Historic District Signs

As part of each quarterly inspection, assessors visit the four Green Level Historic District signs to conduct a visual inspection of each sign to ensure they are in good standing. During this quarterly inspection, all signs were found to be in good condition, with the landscaped areas being well maintained. **Figure 7** shows two of these signs.

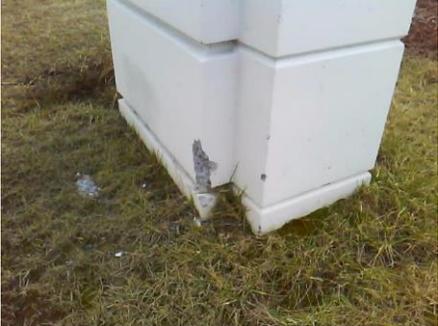
#	Material Type	Object ID	Failure Type	Photo	GIS Reference Page
1	Gantry Support	DS_190	Spalls

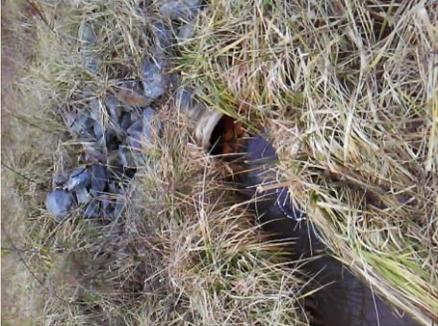
#	Material Type	Object ID	Failure Type	Photo	GIS Reference Page
1	Lateral Pipe	DP_729	Obstruction

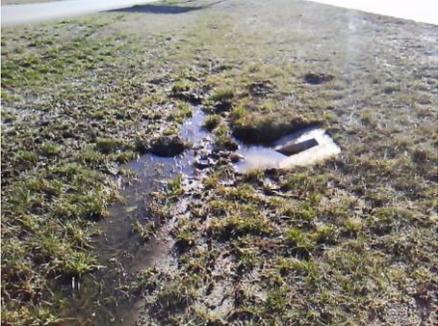
#	Material Type	Object ID	Failure Type	Photo	GIS Reference Page
1	Shoulder Drain	MDP_12	Obstruction

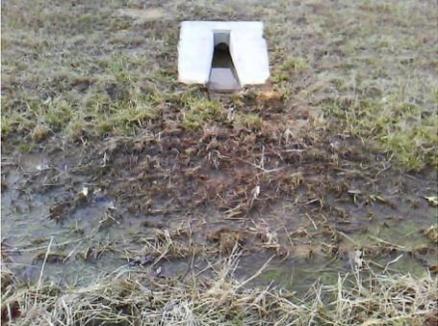
#	Material Type	Object ID	Failure Type	Photo	GIS Reference Page
5	Shoulder Drain	MDP_80	Obstruction

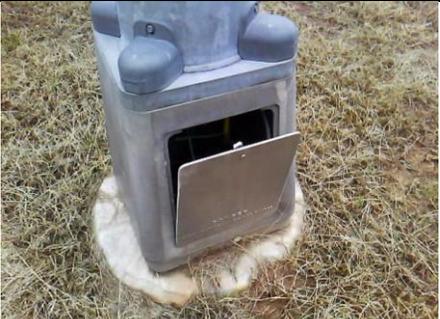
#	Material Type	Object ID	Failure Type	Photo	GIS Reference Page
1	Single Roadway	HL_142	Exposed Electrical Wire

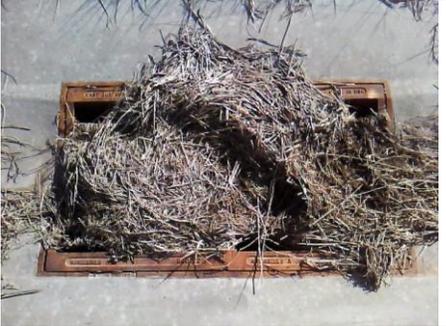
#	Material Type	Object ID	Failure Type	Photo	GIS Reference Page
1	Inlets	IN_252	Obstruction

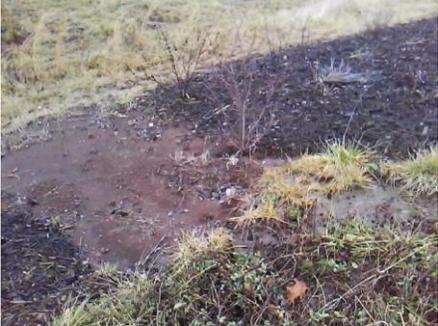
#	Material Type	Object ID	Failure Type	Photo	GIS Reference Page
1	Plant Bed	PB_69	Unhealthy

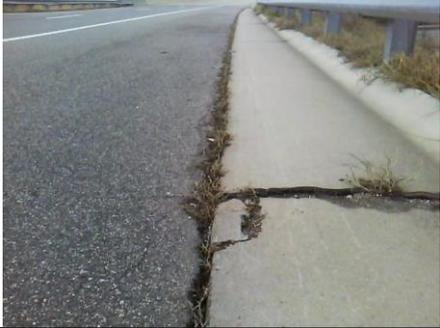
#	Material Type	Object ID	Failure Type	Photo	GIS Reference Page
1	Asphalt	LS_292	Paved Shoulder Joint

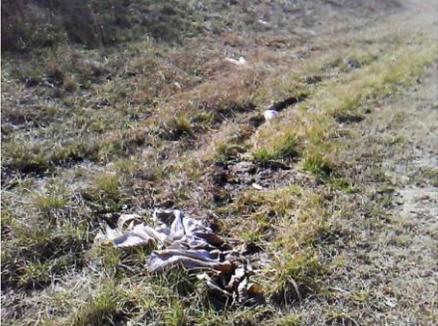
#	Material Type	Object ID	Failure Type	Photo	GIS Reference Page
1	Asphalt	LS_594	Litter

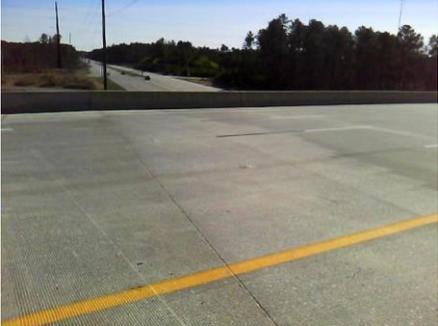
#	Material Type	Object ID	Failure Type	Photo	GIS Reference Page
1	Concrete	LS_35	Missing Markers & Marker Reflectivity

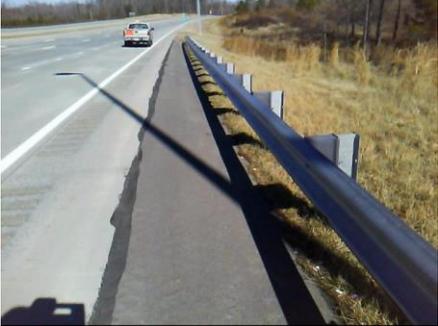
#	Material Type	Object ID	Failure Type	Photo	GIS Reference Page
1	Concrete	LS_88	Missing Markers & Nighttime Reflectivity

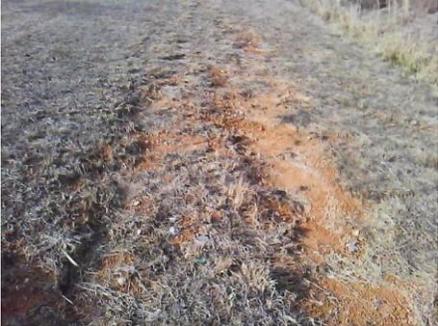
#	Material Type	Object ID	Failure Type	Photo	GIS Reference Page
1	Turf	TF_82	Bareground

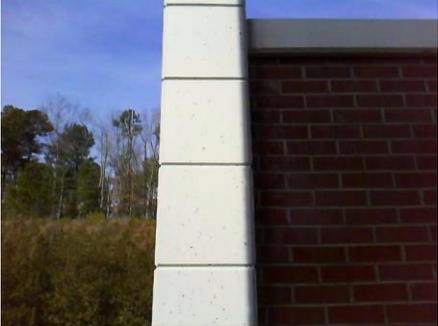
#	Material Type	Object ID	Failure Type	Photo	GIS Reference Page
1	Screen Wall	WL_3	Spalling
