NORTH CAROLINA
Turnpike Authority

Maintenance Rating Program

Triangle Expressway

2015 Second Quarter Report

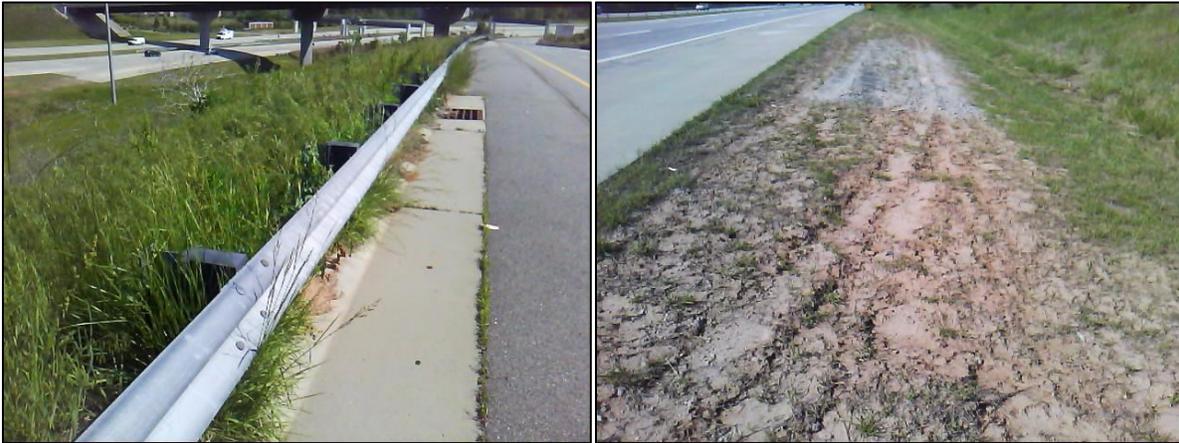
Figure 3: Turf Failures

Turf Condition (50 rating – 37 of the 74 assets failed). Out of the 37 turf areas inspected, 36 failed due to bare ground and one failed due to turf height. Two of the failing turf areas can be seen in the **Figure 3**.

Bare ground areas continue to plague much of the turf along various sections of the Triangle Expressway. The strategy proposed by NCDOT Division 5 Landscape Unit is to add nourishment to the soil through an aggressive fertilizing campaign along with selective hydro-seeding of bare ground areas with warm season grasses beginning in the summer of 2015. As of this report, nourishment and re-seeding activities have not begun and the ratings remain low. Results from this effort may not be immediately recognized as it may take several years for the turf to be fully established. Future MRP assessments will track the progress of the program and continue to report its effectiveness.

Turf Condition is continuing to fail for both the quarterly and the cumulative rolling ratings, and needs the most attention. It is recommended that soil nourishment through an aggressive fertilizing campaign and selective hydro-seeding of bare ground areas with warm season grasses continue throughout the summer of 2015.

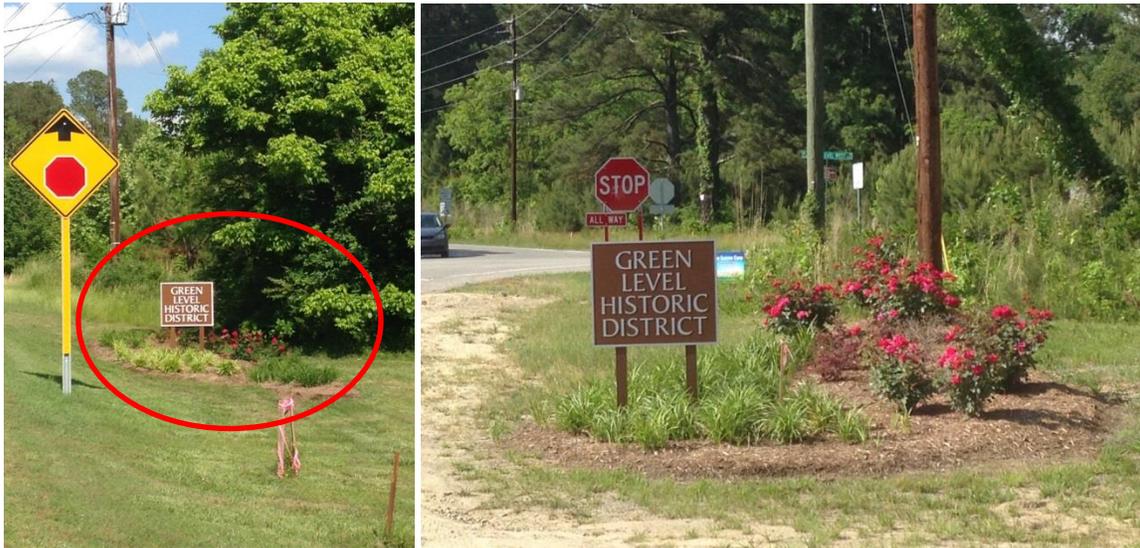
Figure 4: Green Level West Historic District Signs

As part of each quarterly inspection, assessors visit the four Green Level Historic District signs to conduct a visual inspection of each sign to ensure they are in good standing. During this quarterly inspection, all signs were found to be in good condition, with the landscaped areas being well maintained. **Figure 4** shows two of these signs.

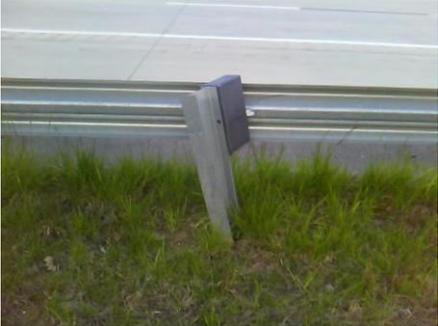
#	Material Type	Object ID	Failure Type	Photo	GIS Reference Page
1	Guardrail	BR_35	Twisted Block

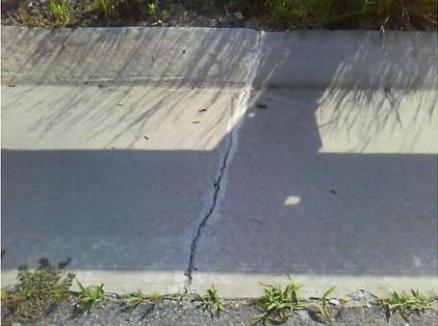
#	Material Type	Object ID	Failure Type	Photo	GIS Reference Page
1	Valley	CG_133	Structural Damage

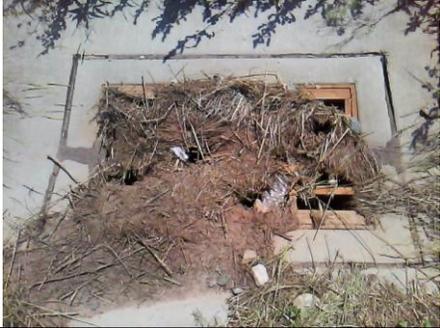
#	Material Type	Object ID	Failure Type	Photo	GIS Reference Page
1	Cross Pipe	DP_318	Obstruction

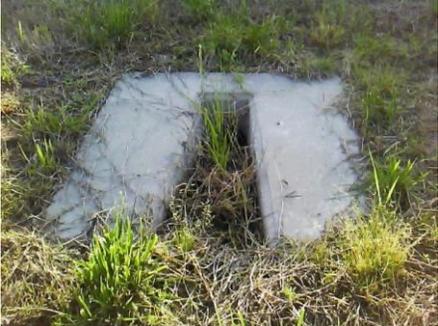
#	Material Type	Object ID	Failure Type	Photo	GIS Reference Page
1	Shoulder Drain	MDP_1	Obstruction

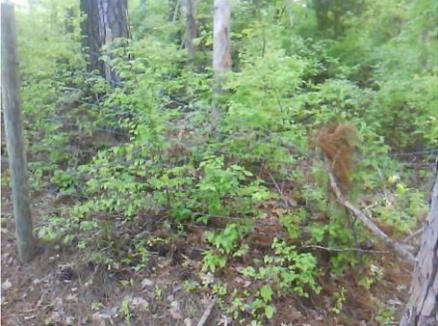
#	Material Type	Object ID	Failure Type	Photo	GIS Reference Page
1	Woven	FN_173	Vegetation Compressing Fence

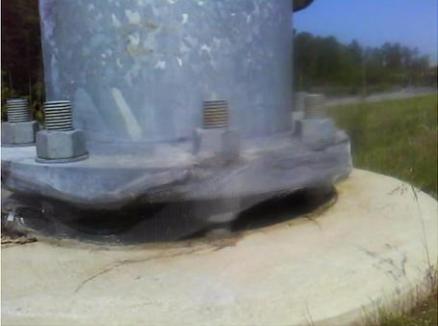
#	Material Type	Object ID	Failure Type	Photo	GIS Reference Page
1	High Mast	HL_92	Damaged Parts

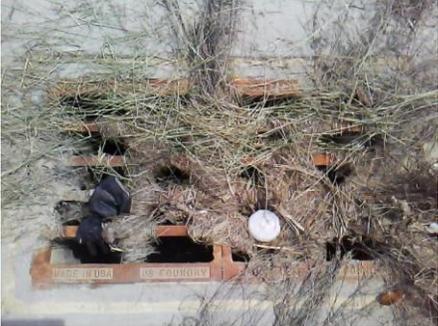
#	Material Type	Object ID	Failure Type	Photo	GIS Reference Page
1	Inlets	IN_826	Obstruction

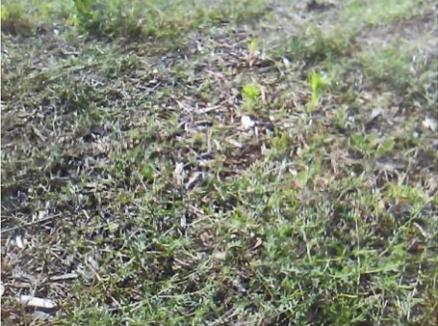
#	Material Type	Object ID	Failure Type	Photo	GIS Reference Page
1	Plant Bed	PB_39	Unwanted Weeds

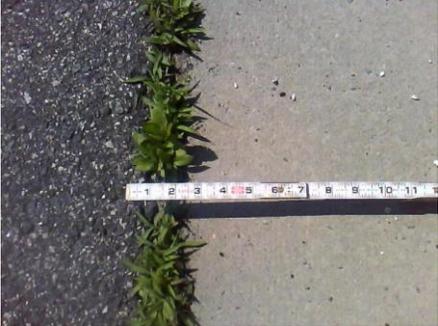
#	Material Type	Object ID	Failure Type	Photo	GIS Reference Page
1	Asphalt	LS_183	Paved Shoulder Joint

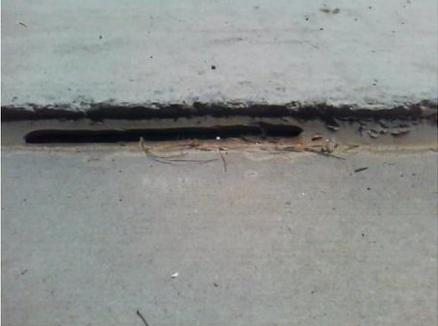
#	Material Type	Object ID	Failure Type	Photo	GIS Reference Page
4	Concrete	LS_493	Paved Shoulder Joint and Settlement

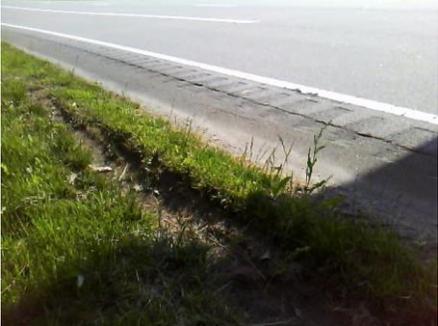
#	Material Type	Object ID	Failure Type	Photo	GIS Reference Page
1	Asphalt	LS_245	Shoulder Dropoff

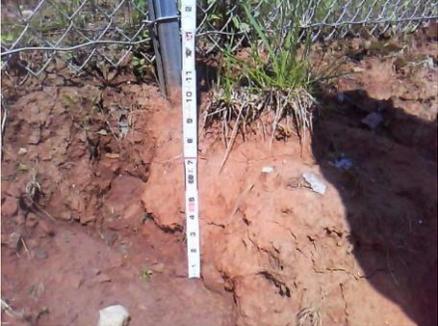
#	Material Type	Object ID	Failure Type	Photo	GIS Reference Page
1	Asphalt	LS_191	Slope Failure

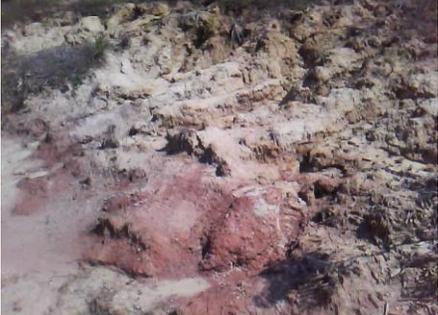
A56, A57
2	Asphalt	LS_213	Slope Failure

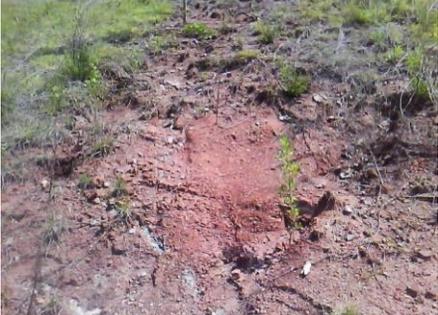
A56
3	Asphalt	LS_227	Slope Failure

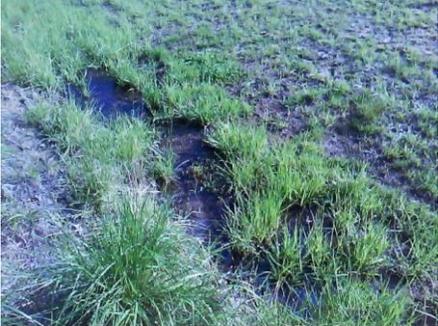
#	Material Type	Object ID	Failure Type	Photo	GIS Reference Page
1	Concrete	LS_432	Blocked Ditch

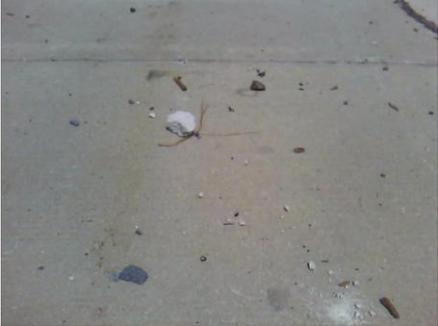
#	Material Type	Object ID	Failure Type	Photo	GIS Reference Page
1	Concrete	LS_338	Roadway Sweeping

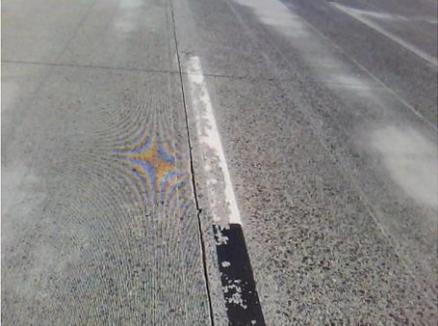
#	Material Type	Object ID	Failure Type	Photo	GIS Reference Page
1	Concrete	LS_405	Line Missing

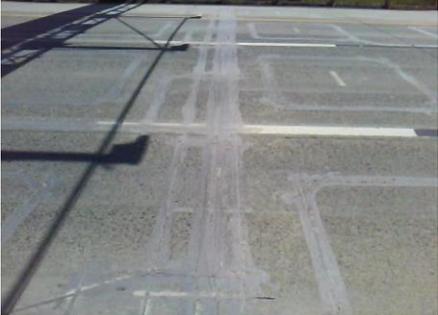
A31, A32
2	Concrete	LS_491	Line Missing

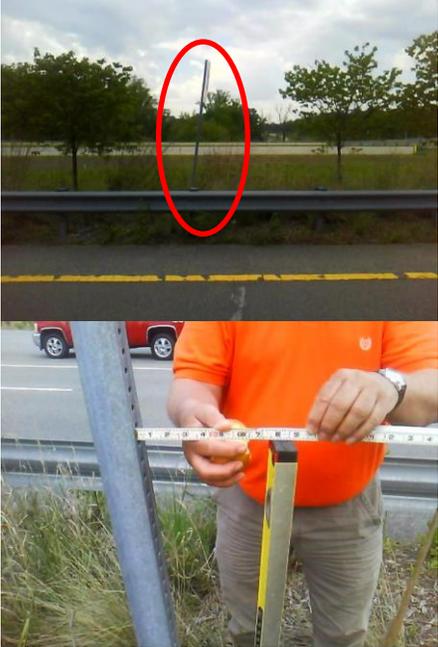
#	Sign Type	Object ID	Failure Type	Photo	GIS Reference Page
1	Do Not Enter	SN_414	Leaning

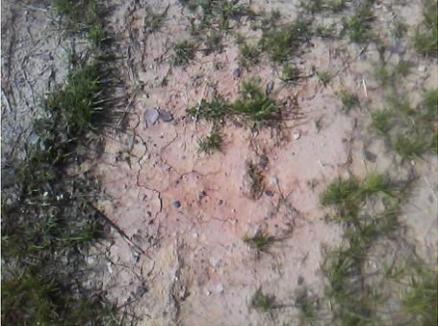
#	Material Type	Object ID	Failure Type	Photo	GIS Reference Page
1	Turf	TF_33	Bareground

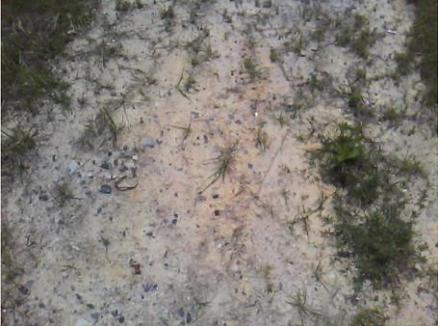
#	Material Type	Object ID	Failure Type	Photo	GIS Reference Page
5	Turf	TF_107	Bareground

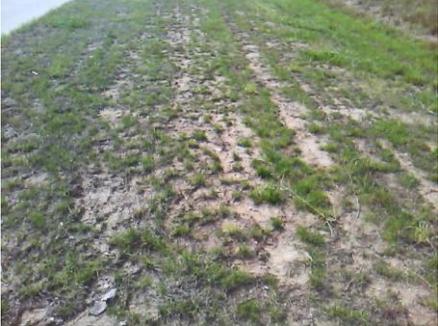
#	Material Type	Object ID	Failure Type	Photo	GIS Reference Page
9	Turf	TF_157	Bareground

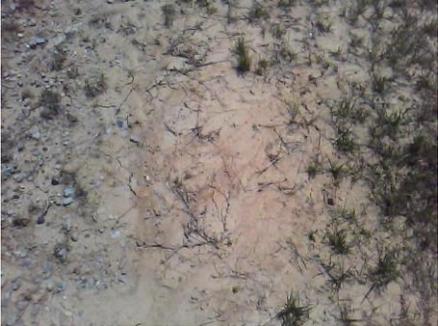
#	Material Type	Object ID	Failure Type	Photo	GIS Reference Page
13	Turf	TF_220	Bareground

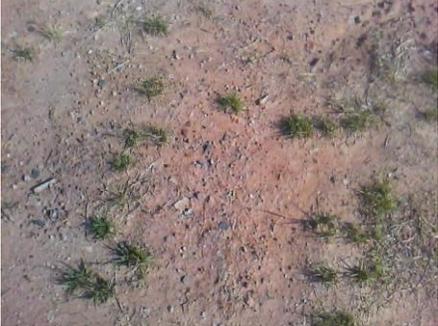
#	Material Type	Object ID	Failure Type	Photo	GIS Reference Page
17	Turf	TF_263	Bareground

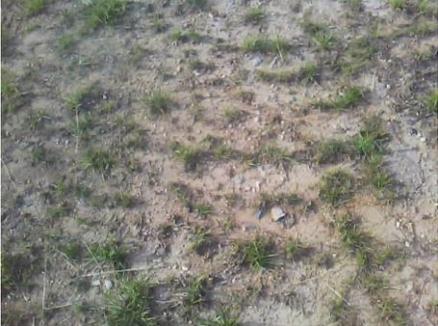
#	Material Type	Object ID	Failure Type	Photo	GIS Reference Page
21	Turf	TF_493	Bareground

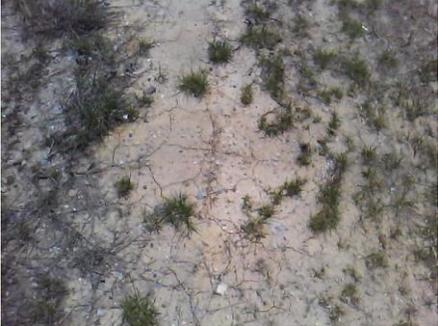
#	Material Type	Object ID	Failure Type	Photo	GIS Reference Page
25	Turf	TF_568	Bareground

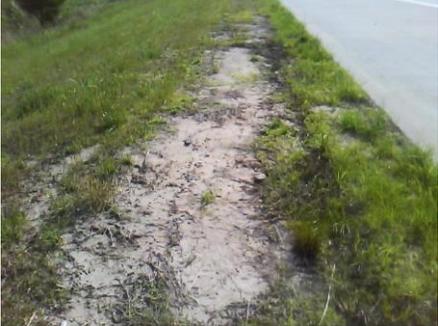
#	Material Type	Object ID	Failure Type	Photo	GIS Reference Page
29	Turf	TF_721	Bareground

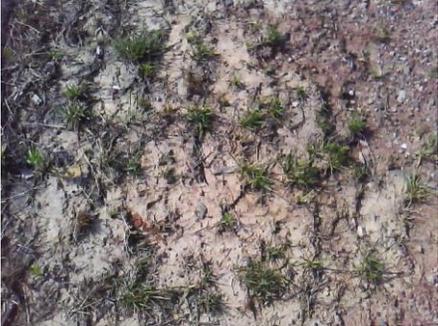
#	Material Type	Object ID	Failure Type	Photo	GIS Reference Page
33	Turf	TF_890	Bareground

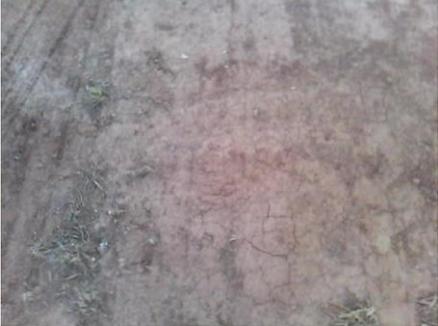
#	Material Type	Object ID	Failure Type	Photo	GIS Reference Page
37	Turf	TF_963	Bareground

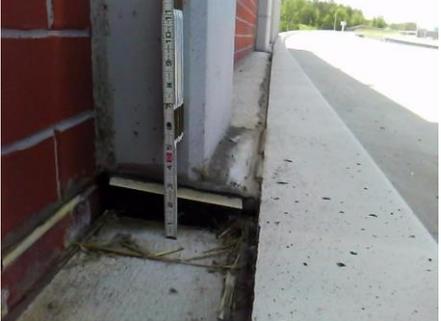
#	Material Type	Object ID	Failure Type	Photo	GIS Reference Page
1	Sound Wall	WL_95	Joint Separation
