NORTH CAROLINA
Turnpike Authority

Maintenance Rating Program Triangle Expressway

2014 Second Quarter Ratings

Maintenance Rating Program for the Triangle Expressway

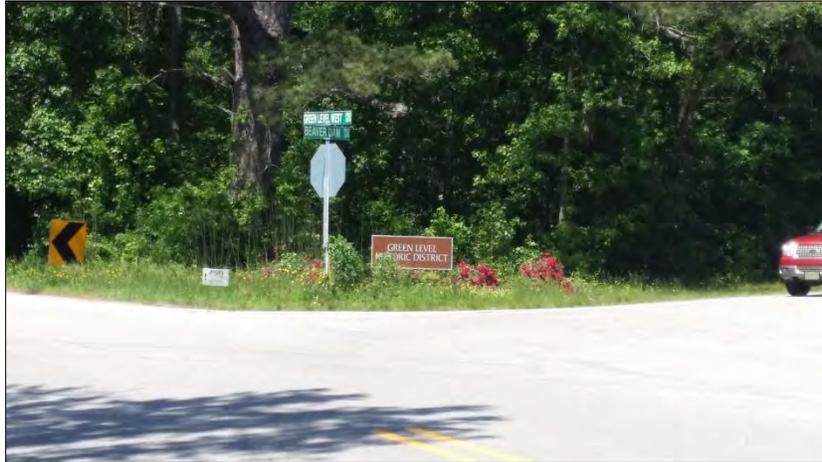
Figure 4: Green Level West Historical District Signs

These signs were visually inspected as part of this quarterly inspection and were found to all be in good condition. However, as shown in the picture below, the landscaped areas surrounding the signs now contain numerous weeds and have started to look unsightly and overgrown. In several instances, part of the signs has become blocked from the vegetation, which can be seen in **Figure 4**.

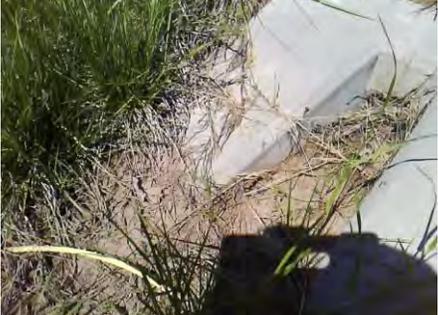
A photograph showing a concrete shoulder drain partially blocked by a large, light-colored plastic bag or debris. The drain is surrounded by dry grass and some green weeds.	A13, A14
2	Shoulder Drain	MDP_44	Obstruction

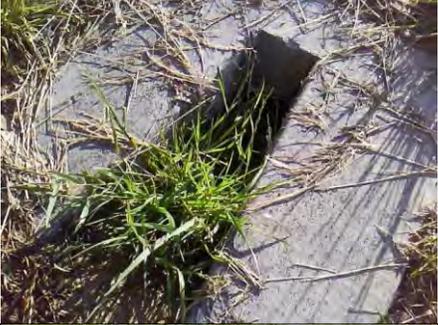
A photograph showing a concrete shoulder drain heavily obstructed by a large, light-colored plastic bag. The surrounding area is overgrown with tall grass and weeds.	A17
3	Shoulder Drain	MDP_95	Obstruction

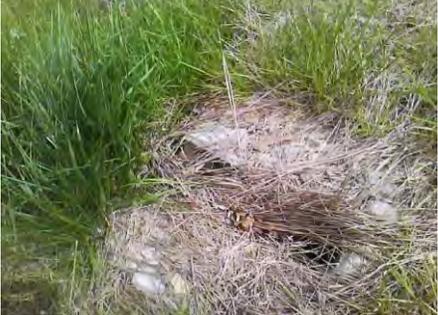
A photograph showing a concrete shoulder drain with a significant obstruction of dry grass and debris. A shadow is cast across the drain, indicating the sun is high.	A28, A29
4	Shoulder Drain	MDP_169	Obstruction

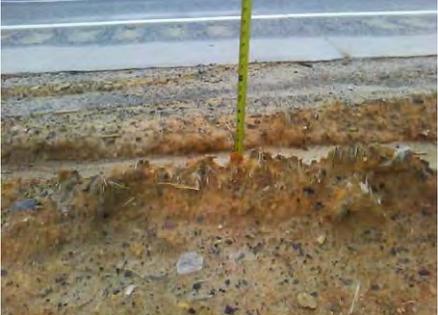
A1, A2
6	Unpaved Shoulder	LS_599	Shoulder Drop-off

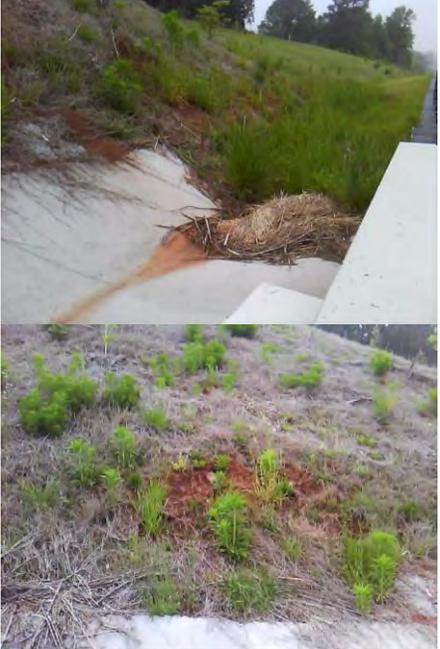
A51, A52
2	Paved Ditch	PD_19	Material Accumulation and Erosion

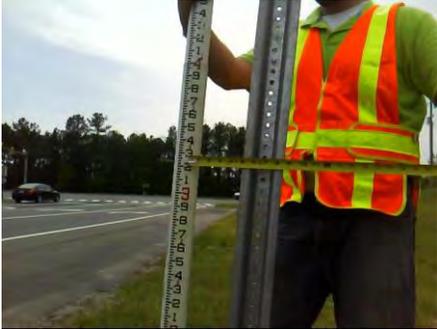
A54, A55
4	NC Route	SN_498	Leaning and Sign Support

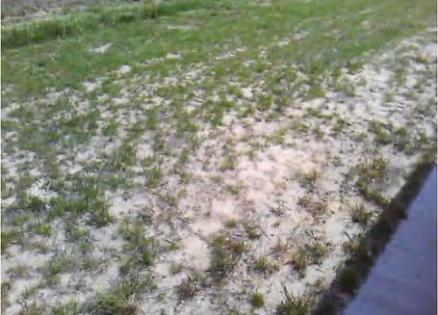
A14
2	Turf	TF_30	Bareground

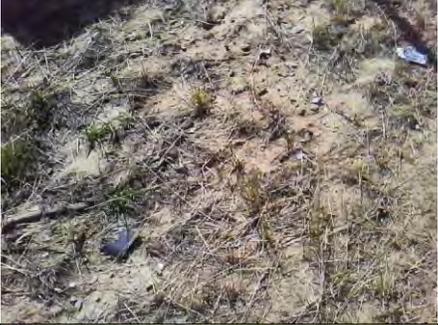
A23
3	Turf	TF_55	Bareground

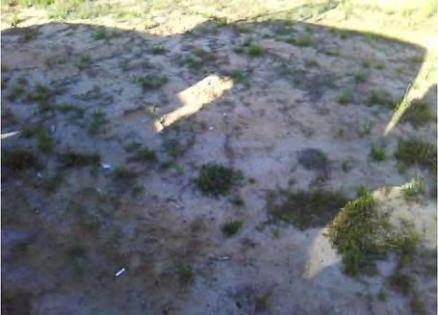
A26
6	Turf	TF_70	Bareground

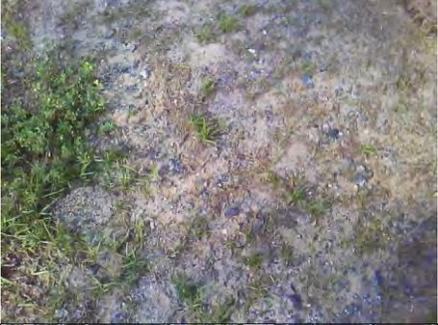
A25, A26
7	Turf	TF_107	Bareground

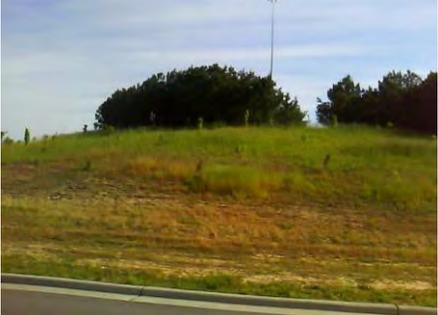
A20
10	Turf	TF_182	Bareground

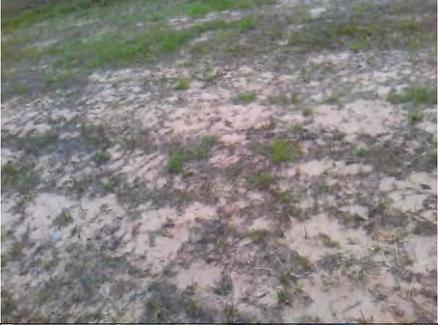
A27, A28, A29
11	Turf	TF_204	Bareground

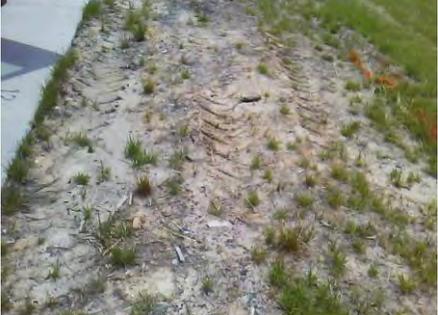
A39, A40, A41
14	Turf	TF_304	Bareground

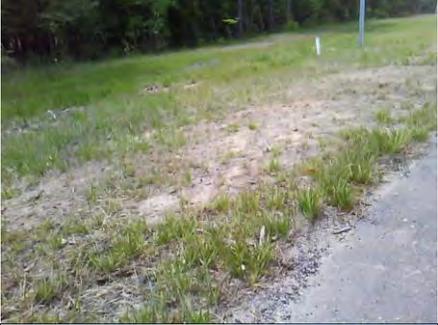
A45, A46
15	Turf	TF_309	Bareground

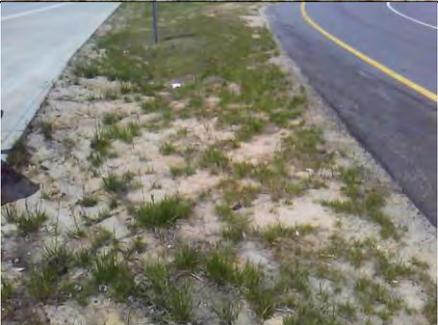
A39, A40, A42
18	Turf	TF_433	Bareground

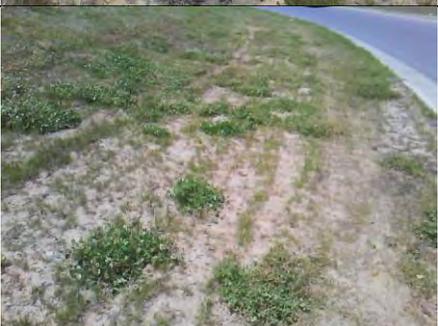
A37
19	Turf	TF_456	Bareground

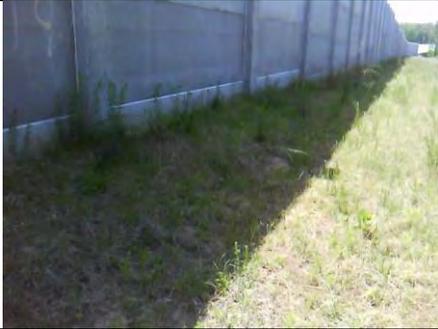
A46
22	Turf	TF_482	Undesirable vegetation

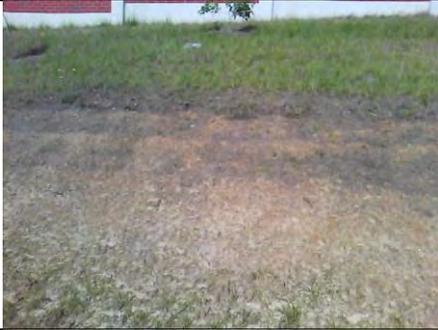
A33, A34
23	Turf	TF_484	Bareground

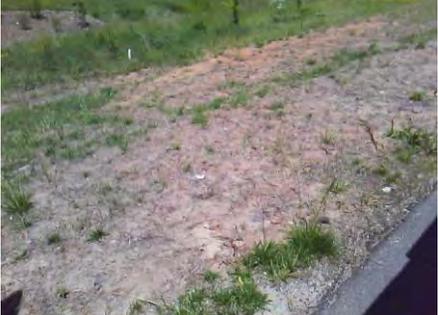
A56, A57
26	Turf	TF_863	Bareground

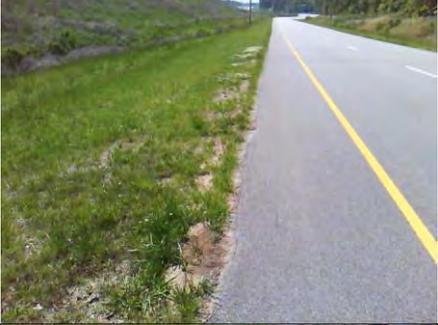
A55
27	Turf	TF_887	Noxious Weeds

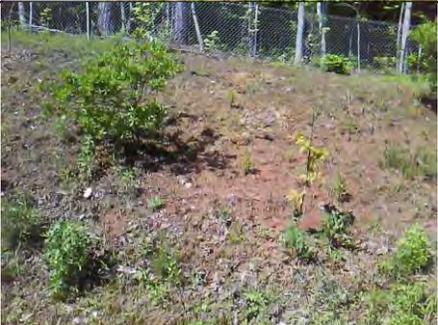
A54
30	Turf	TF_913	Bareground

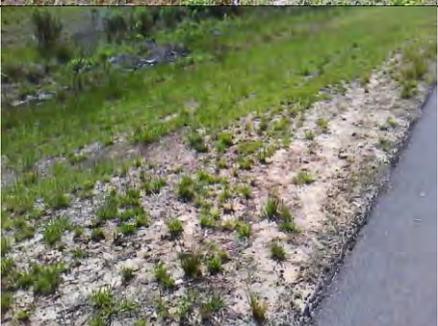
A51, A52
31	Turf	TF_936	Bareground
