NORTH CAROLINA
Turnpike Authority

Maintenance Rating Program

Triangle Expressway

2015 Third Quarter Report

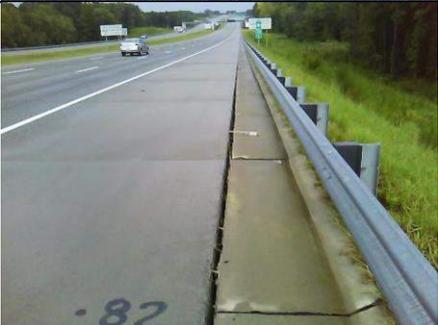
A5
2	Valley	CG_183	Misalignment

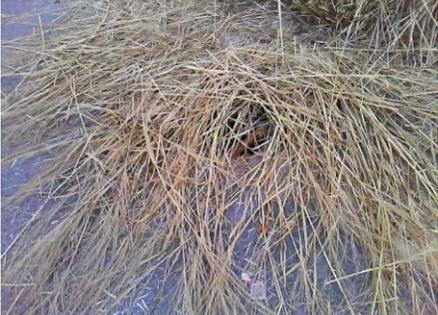
A22
2	Lateral Pipe	DP_167	Obstruction

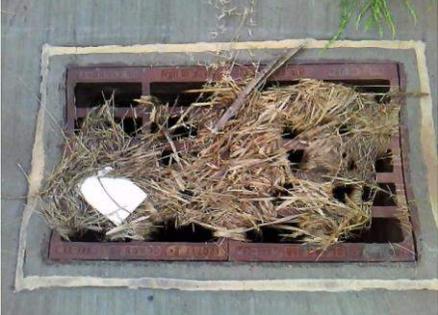
A5
3	Cross Pipe	DP_739	Obstruction

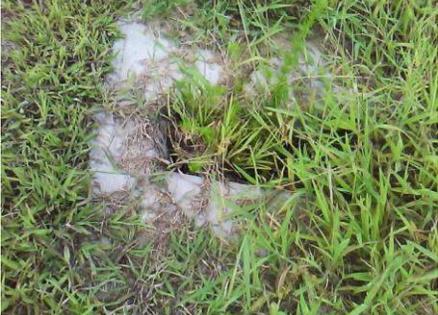
A21, A22
2	Shoulder Drain	MDP_88	Obstruction

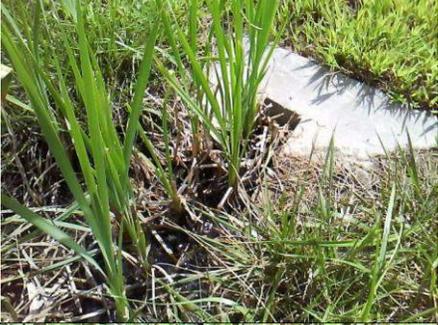
A27
3	Shoulder Drain	MDP_150	Obstruction

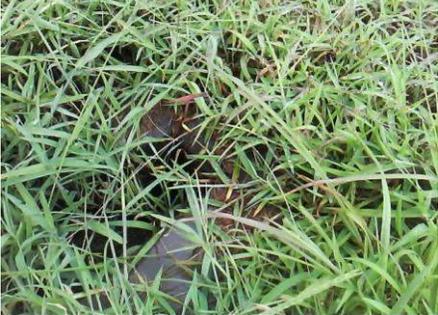
A39
4	Shoulder Drain	MDP_165	Obstruction

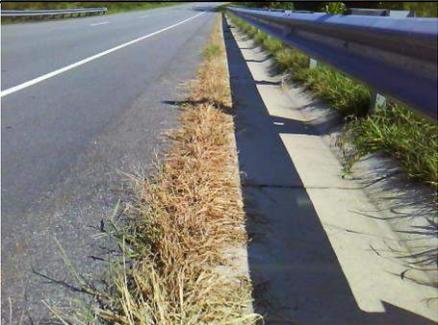
A15, A16
2	Asphalt	LS_219	Paved Shoulder Joint

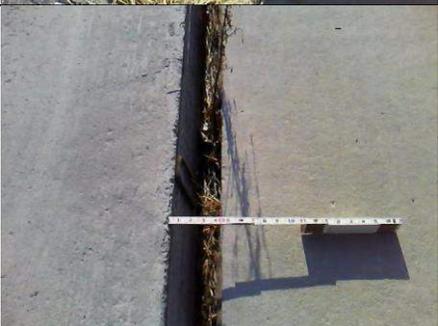
A54, A55
3	Concrete	LS_486	Paved Shoulder Joint

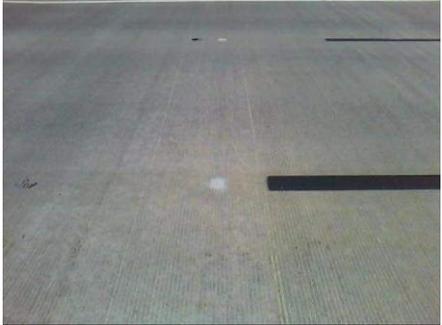
A41
6	Asphalt	LS_596	Marker Reflectivity	Not Available for Nighttime Failure	A29
7	Concrete	LS_603	Marker Reflectivity, Missing Markers and Continous Markers

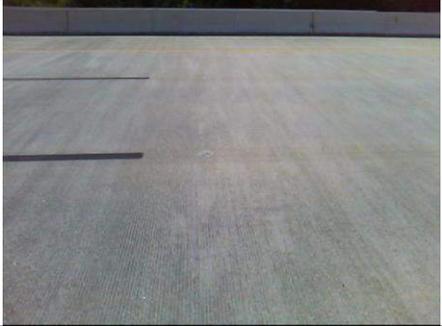
A33, A34
8	Concrete	LS_604	Marker Reflectivity, Missing Markers and Continous Markers

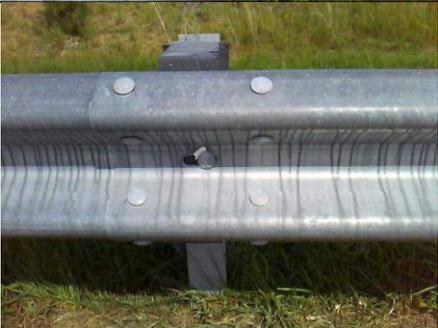
A13
2	Concrete	LS_76	Nighttime Reflectivity and Missing Parts

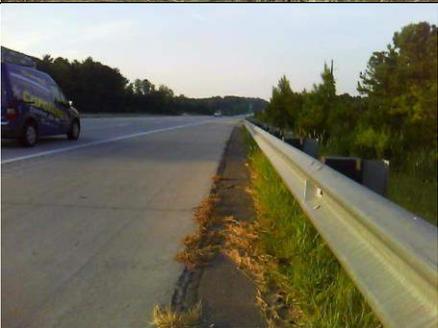
A24
3	Concrete	LS_112	Nighttime Reflectivity and Missing Parts

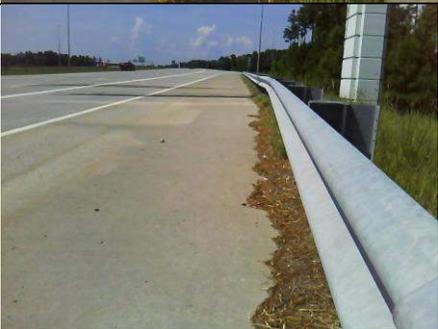
A15, A16
4	Concrete	LS_335	Nighttime Reflectivity and Missing Parts

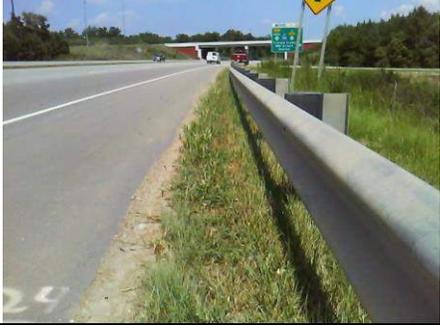
A42
6	Asphalt	LS_386	Nighttime Reflectivity and Missing Parts

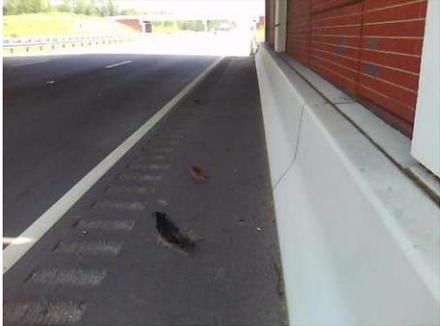
A47
7	Asphalt	LS_553	Nighttime Reflectivity	Not Available for Nighttime Failure	A42
8	Asphalt	LS_560	Nighttime Reflectivity and Missing Parts

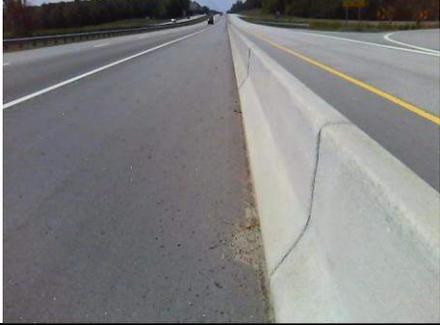
A41
9	Asphalt	LS_597	Nighttime Reflectivity and Missing Parts

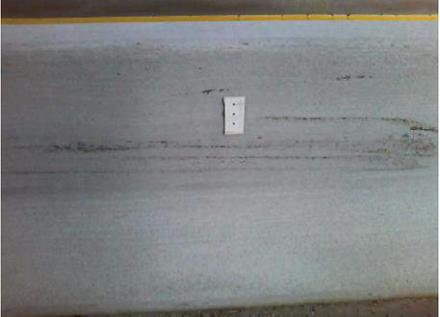
#	Material Type	Object ID	Failure Type	Photo	GIS Reference Page
10	Asphalt	LS_598	Nighttime Reflectivity and Missing Parts

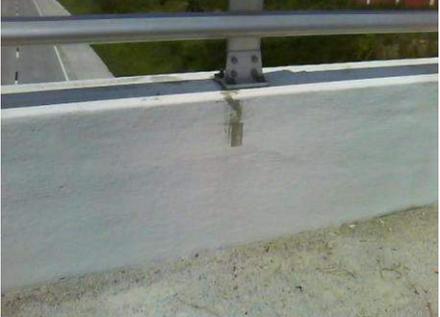
A41
11	Asphalt	LS_391	Nighttime Reflectivity and Missing Parts

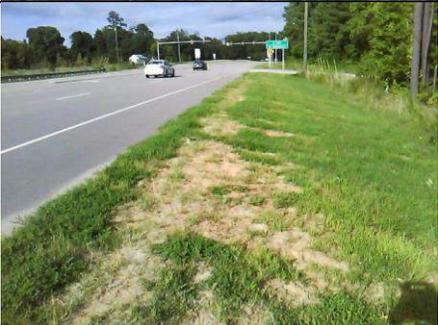
A22, A23
2	Turf	TF_57	Bareground

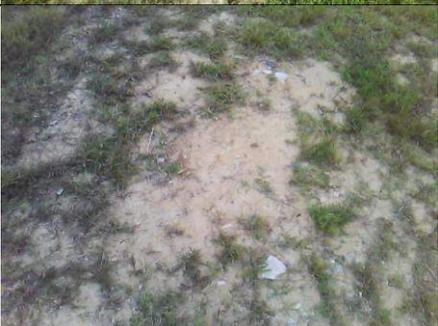
A22
3	Turf	TF_71	Bareground

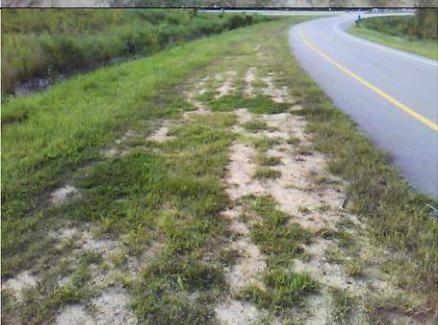
A27, A28
4	Turf	TF_79	Bareground

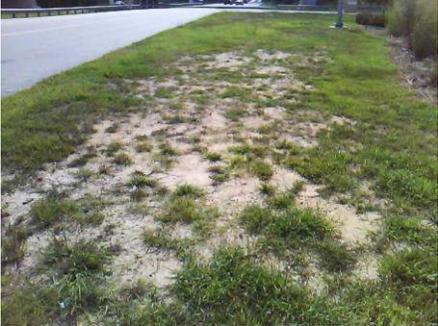
#	Material Type	Object ID	Failure Type	Photo	GIS Reference Page
5	Turf	TF_90	Bareground

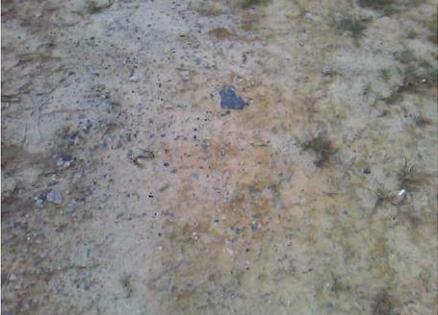
A29
6	Turf	TF_94	Bareground

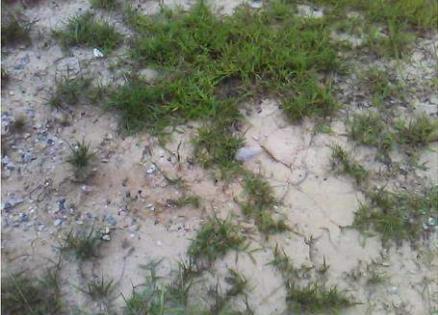
A37
7	Turf	TF_110	Bareground

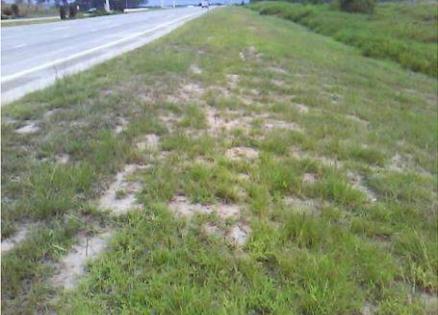
A31, A32
8	Turf	TF_142	Bareground

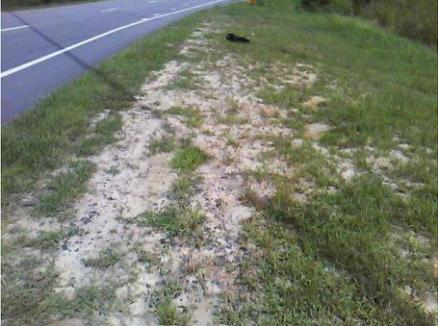
#	Material Type	Object ID	Failure Type	Photo	GIS Reference Page
9	Turf	TF_149	Bareground

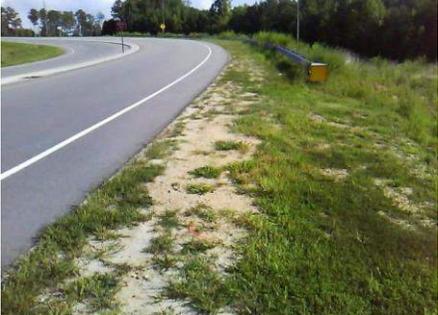
A40
10	Turf	TF_165	Bareground

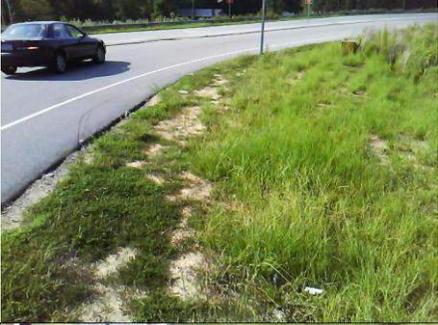
A29
11	Turf	TF_222	Bareground

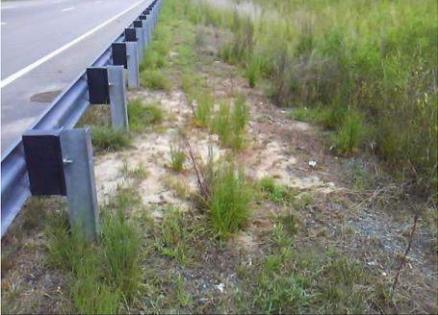
A29
12	Turf	TF_244	Bareground

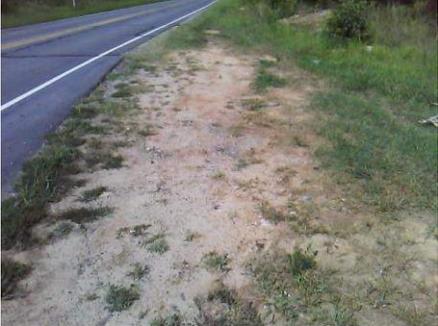
#	Material Type	Object ID	Failure Type	Photo	GIS Reference Page
13	Turf	TF_275	Bareground

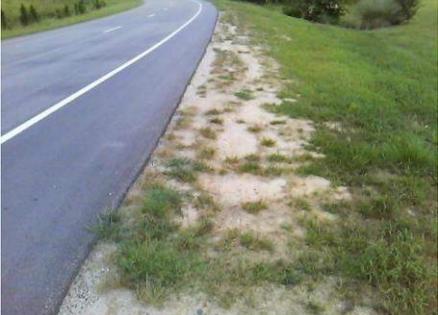
A37
14	Turf	TF_342	Bareground

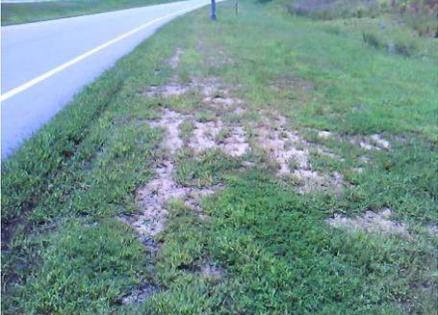
A40, A41
15	Turf	TF_370	Bareground

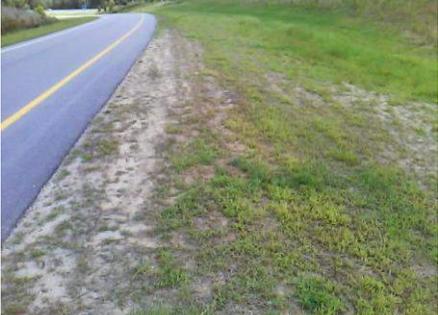
A41, A42
16	Turf	TF_372	Bareground

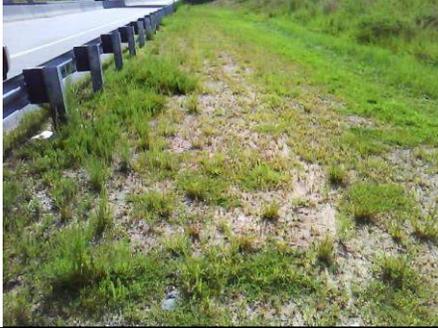
#	Material Type	Object ID	Failure Type	Photo	GIS Reference Page
17	Turf	TF_376	Bareground

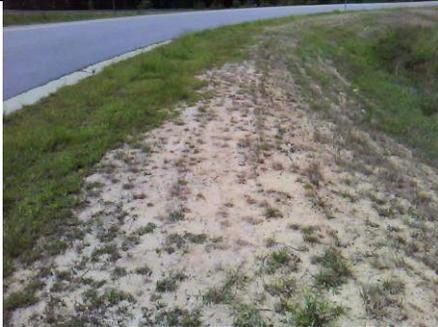
A41
18	Turf	TF_382	Bareground

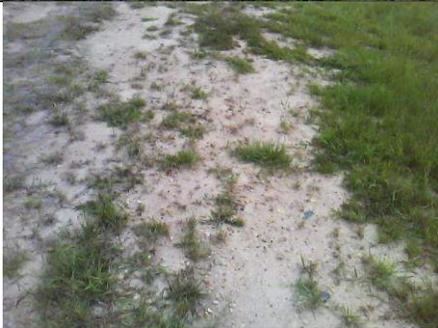
A40, A41
19	Turf	TF_390	Bareground

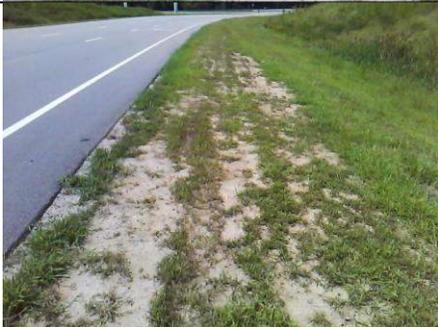
A39, A41
20	Turf	TF_393	Bareground

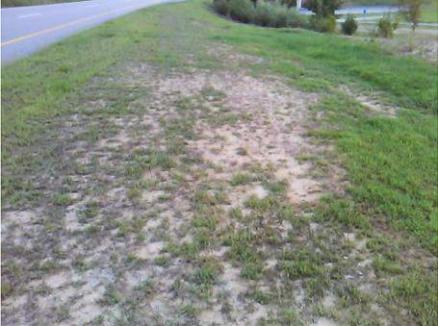
#	Material Type	Object ID	Failure Type	Photo	GIS Reference Page
21	Turf	TF_394	Bareground

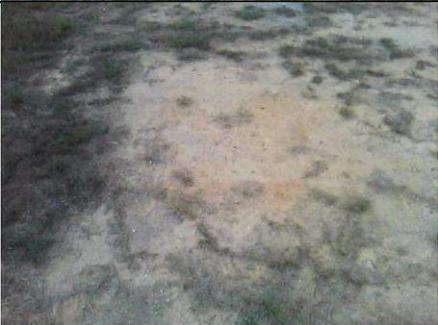
A39, A41
22	Turf	TF_398	Bareground

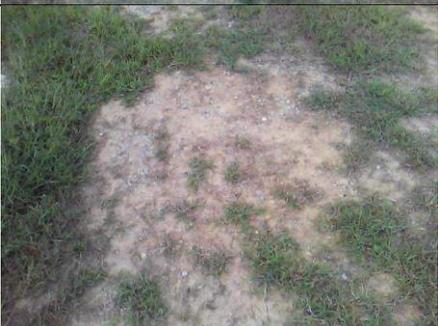
A39, A41
23	Turf	TF_400	Bareground

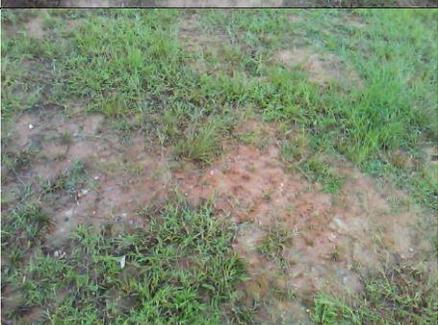
A39
24	Turf	TF_433	Bareground

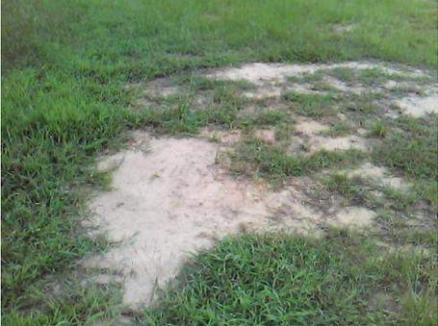
#	Material Type	Object ID	Failure Type	Photo	GIS Reference Page
25	Turf	TF_442	Bareground

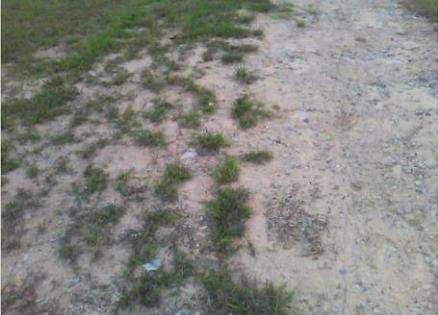
A35, A36
26	Turf	TF_536	Bareground

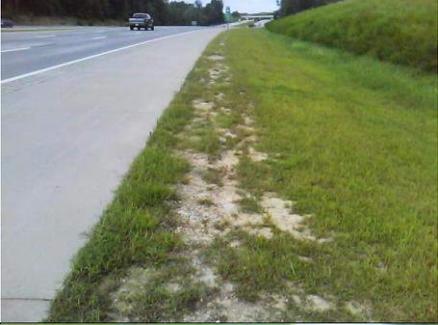
A28
27	Turf	TF_546	Bareground

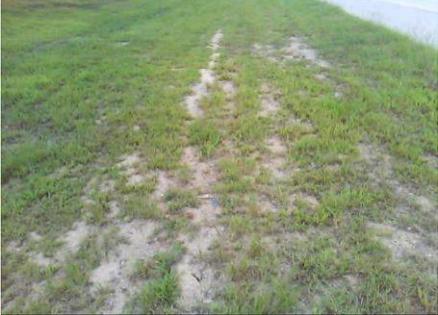
A27
28	Turf	TF_551	Bareground

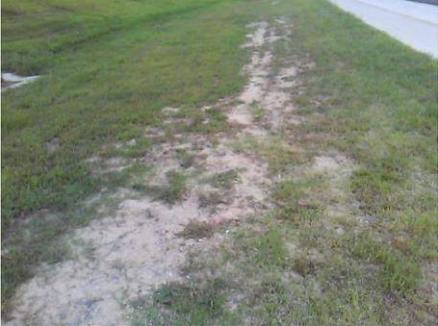
#	Material Type	Object ID	Failure Type	Photo	GIS Reference Page
29	Turf	TF_559	Bareground

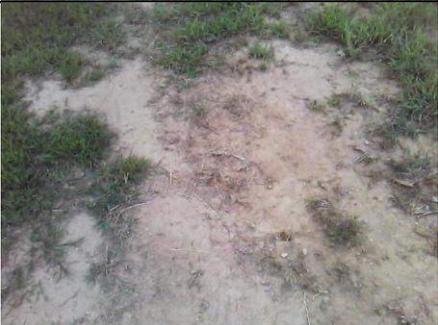
A25
30	Turf	TF_592	Bareground

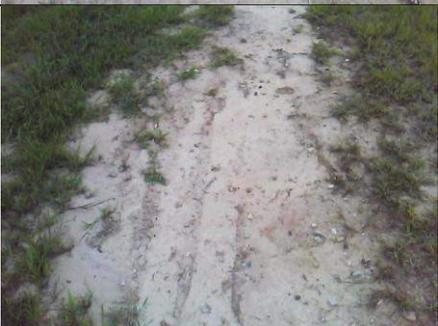
A21
31	Turf	TF_619	Bareground

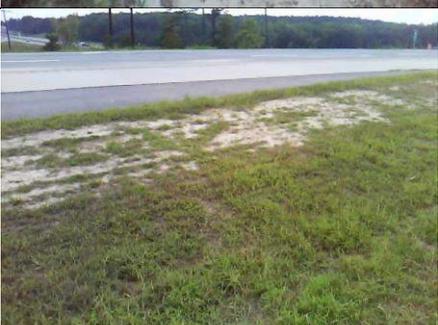
A18
32	Turf	TF_659	Bareground

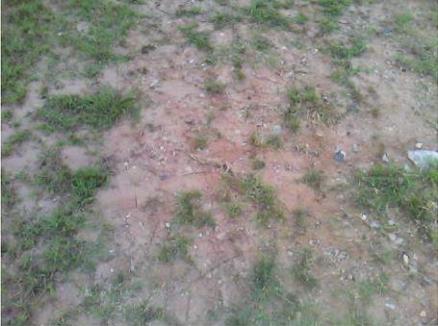
#	Material Type	Object ID	Failure Type	Photo	GIS Reference Page
33	Turf	TF_673	Bareground

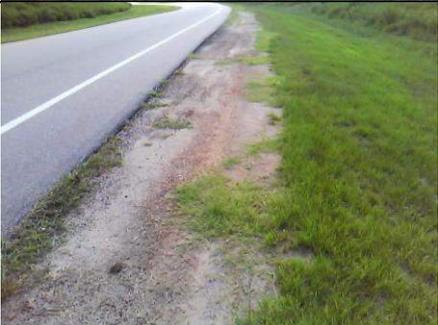
A12, A13
34	Turf	TF_712	Bareground

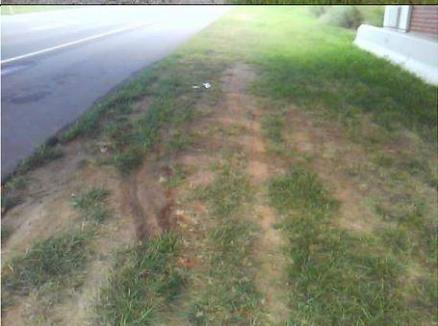
A10
35	Turf	TF_755	Bareground

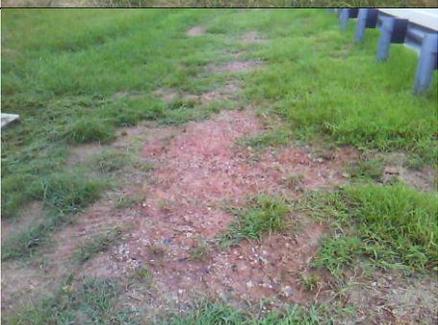
A57
36	Turf	TF_830	Bareground

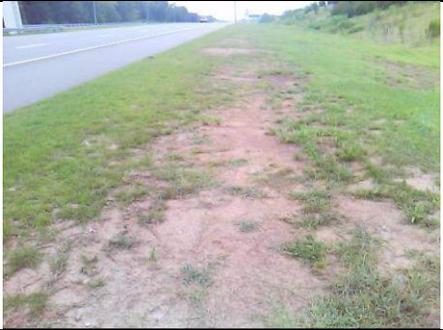
#	Material Type	Object ID	Failure Type	Photo	GIS Reference Page
37	Turf	TF_852	Bareground

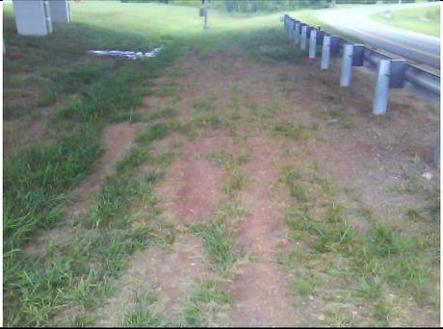
A56, A57
38	Turf	TF_970	Bareground

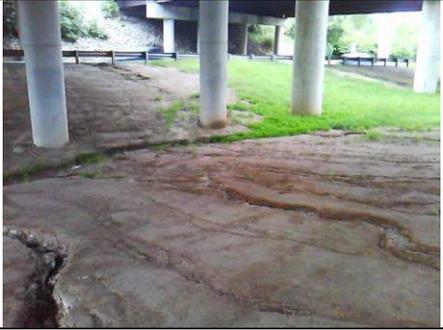
A49, A50
39	Turf	TF_1007	Bareground

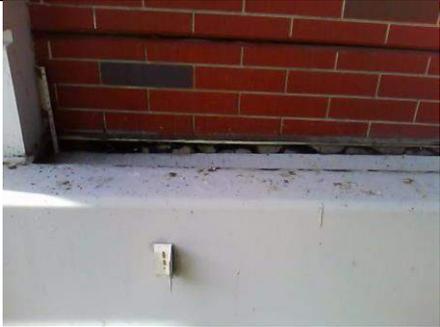
A29, A30
2	Sound Wall	WL_63	Joint Separation

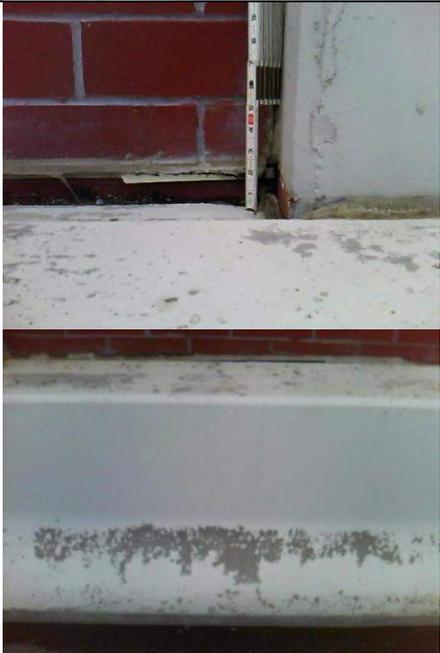
A41
3	Sound Wall	WL_96	Joint Separation and Paint Scaling

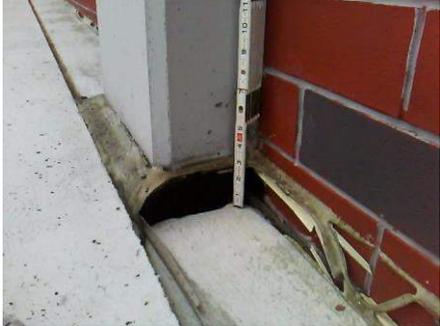
#	Material Type	Object ID	Failure Type	Photo	GIS Reference Page
4	Sound Wall	WL_99	Joint Separation
