NORTH CAROLINA
Turnpike Authority

Maintenance Rating Program

Triangle Expressway

2015 First Quarter Report

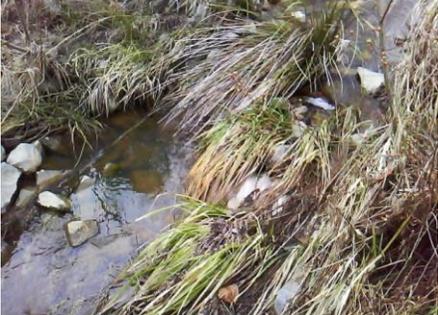
A47
2	Drain	DP_840	Obstruction

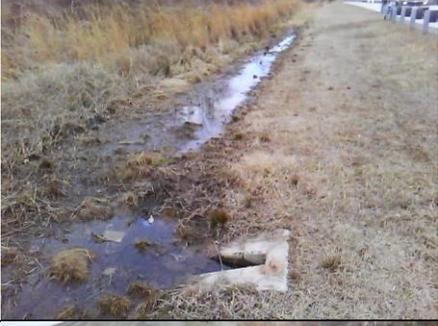
A12
2	Shoulder Drain	MDP_39	Obstruction

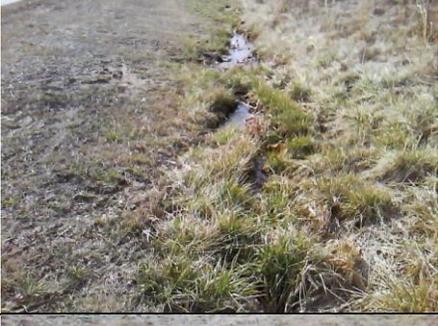
A18, A19
3	Shoulder Drain	MDP_42	Obstruction

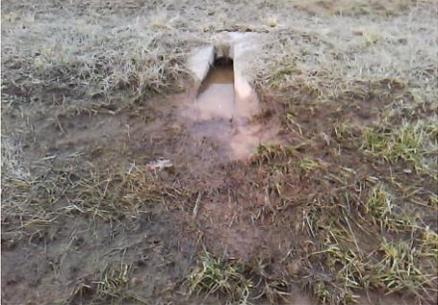
A19
4	Shoulder Drain	MDP_50	Obstruction

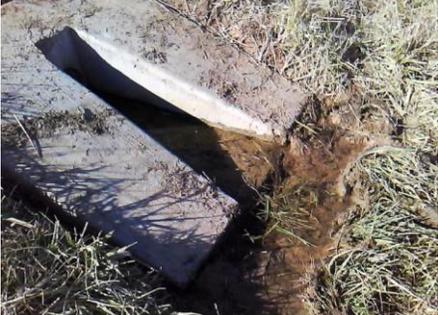
A26, A27
6	Shoulder Drain	MDP_99	Obstruction

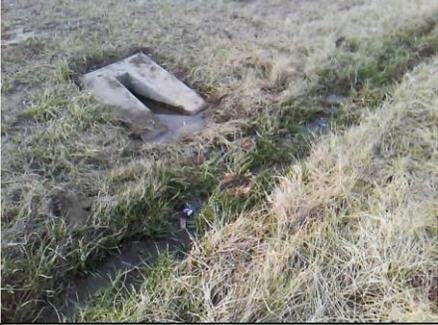
A32
7	Shoulder Drain	MDP_107	Obstruction

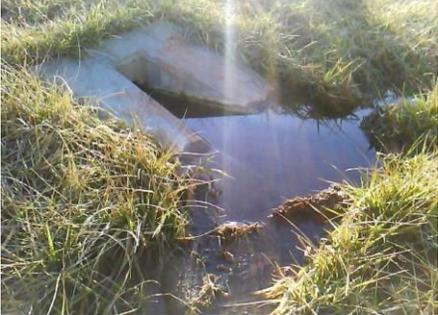
A33
8	Shoulder Drain	MDP_166	Obstruction

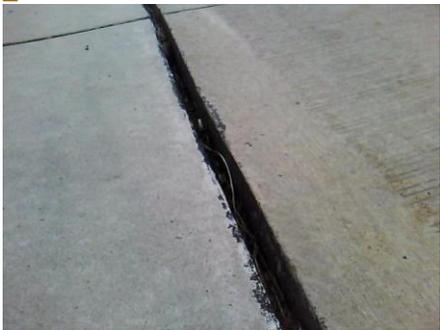
A6
2	Concrete	LS_309	Paved Shoulder Joint

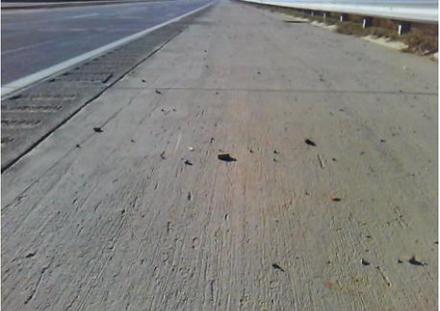
#	Material Type	Object ID	Failure Type	Photo	GIS Reference Page
1	Concrete	LS_114	Roadway Sweeping

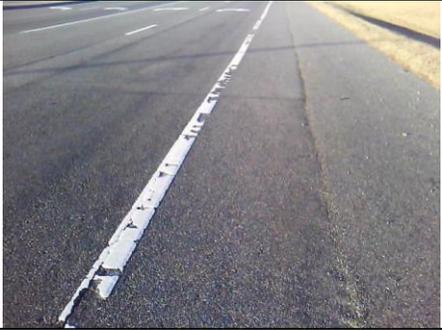
#	Material Type	Object ID	Failure Type	Photo	GIS Reference Page
1	Concrete	LS_70	Nighttime Line Visibility	Not Available for Nighttime Failure.	A22, A23
2	Asphalt	LS_299	Line Width

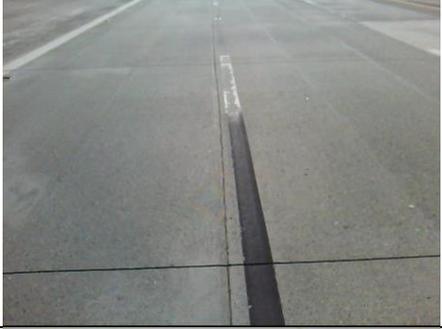
A2
3	Concrete	LS_306	Nighttime Line Visibility	Not Available for Nighttime Failure.	A4, A5
4	Concrete	LS_309	Nighttime Line Visibility	Not Available for Nighttime Failure.	A2, A4
5	Concrete	LS_441	Missing Line

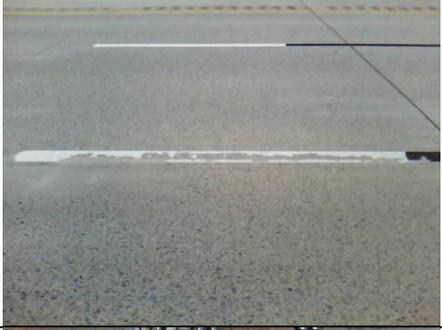
A38
6	Concrete	LS_474	Missing Line

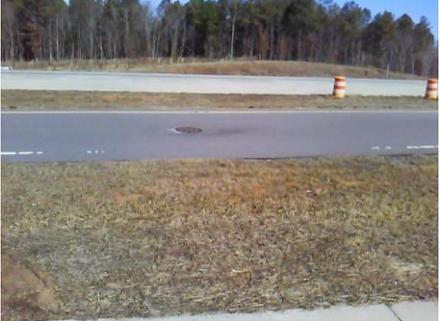
#	Material Type	Object ID	Failure Type	Photo	GIS Reference Page
8	Concrete	LS_496	Missing Line

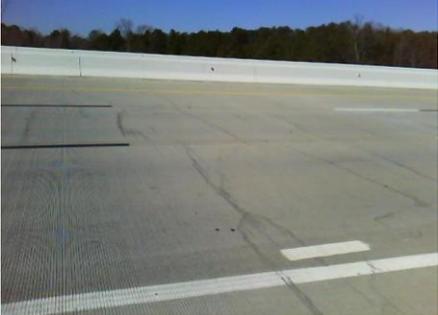
A10, A11, A12
2	Concrete	LS_37	Missing Markers & Marker Reflectivity

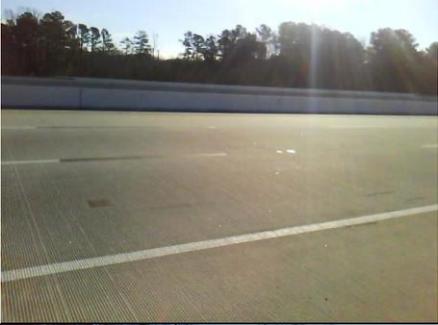
A12, A13
3	Concrete	LS_114	Missing Markers & Marker Reflectivity

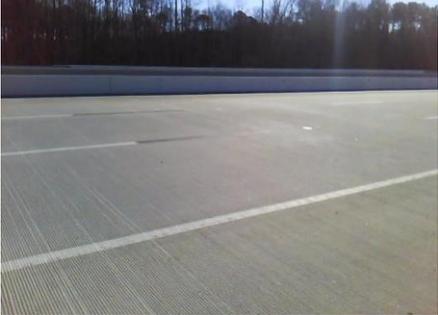
A16, A17
4	Concrete	LS_139	Missing Markers & Marker Reflectivity

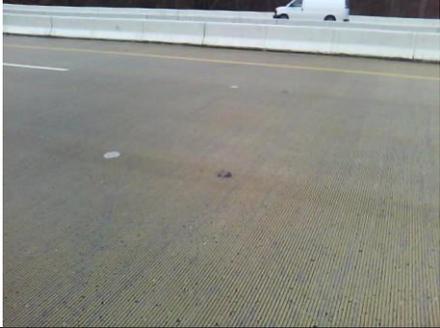
#	Material Type	Object ID	Failure Type	Photo	GIS Reference Page
7	Asphalt	LS_237	Missing Markers & Marker Reflectivity

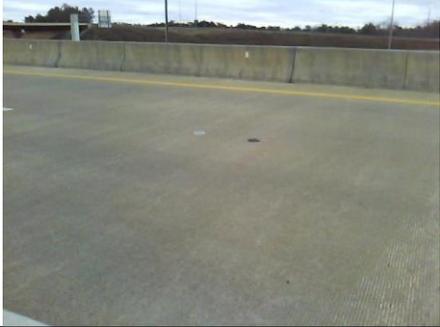
A51, A52
8	Asphalt	LS_239	Marker Reflectivity	Not Available for Nighttime Failure.	A51
9	Asphalt	LS_264	Marker Reflectivity	Not Available for Nighttime Failure.	A52, A53
10	Asphalt	LS_285	Marker Reflectivity	Not Available for Nighttime Failure.	A57
11	Asphalt	LS_292	Missing Markers & Marker Reflectivity

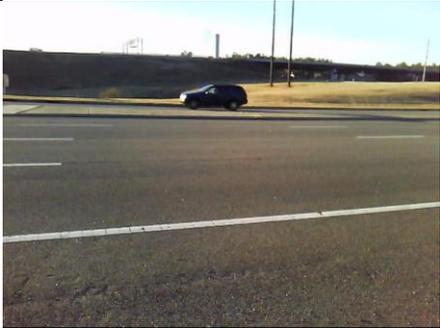
A6
12	Asphalt	LS_295	Marker Reflectivity	Not Available for Nighttime Failure.	A7
13	Asphalt	LS_299	Missing Markers & Marker Reflectivity

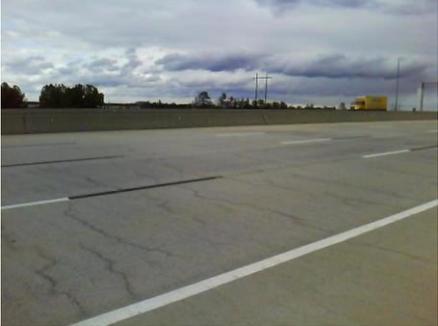
#	Material Type	Object ID	Failure Type	Photo	GIS Reference Page
14	Concrete	LS_309	Missing Markers & Marker Reflectivity

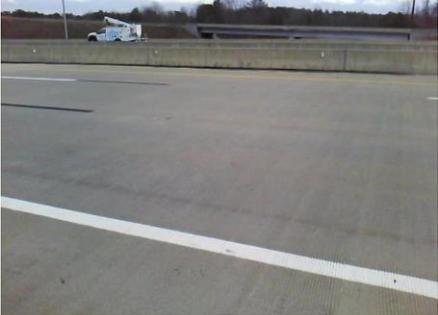
A2, A4
15	Concrete	LS_326	Missing Markers & Marker Reflectivity

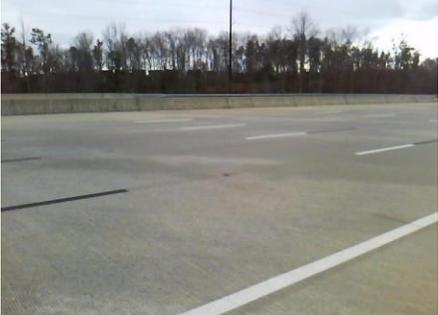
A6, A7
16	Concrete	LS_330	Missing Markers & Marker Reflectivity

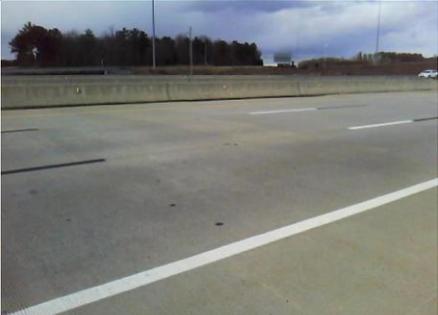
A7, A8
17	Concrete	LS_347	Missing Markers & Marker Reflectivity

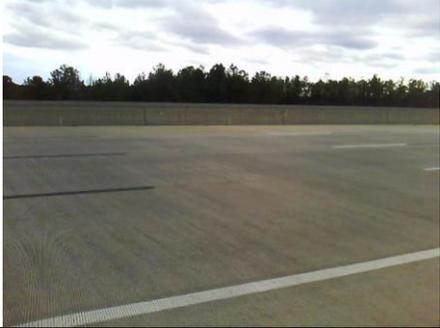
#	Material Type	Object ID	Failure Type	Photo	GIS Reference Page
18	Concrete	LS_356	Missing Markers & Marker Reflectivity

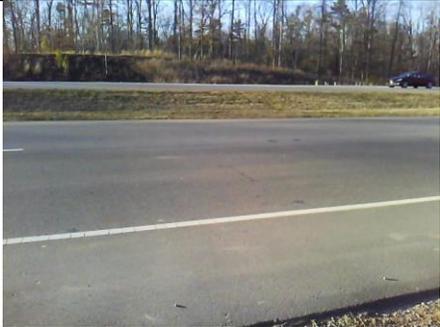
A2
19	Asphalt	LS_387	Missing Markers & Marker Reflectivity

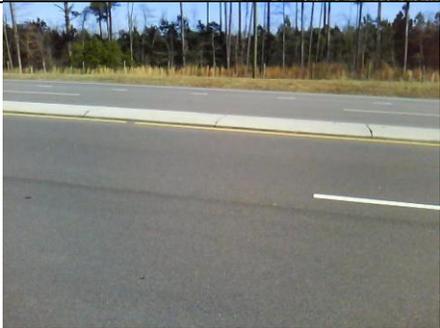
A48, A49
20	Asphalt	LS_576	Missing Markers & Marker Reflectivity

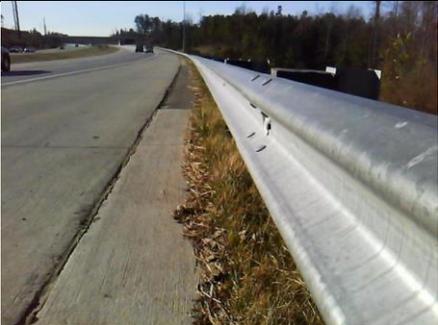
A28, A29
2	Concrete	LS_107	Missing Markers & Nighttime Reflectivity

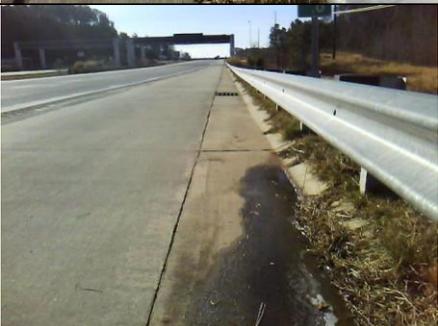
A14
3	Concrete	LS_129	Missing Markers & Nighttime Reflectivity

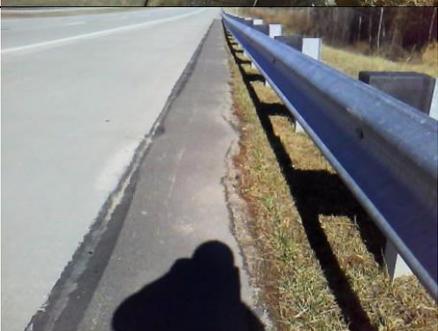
A20, A21
4	Concrete	LS_429	Missing Markers & Nighttime Reflectivity

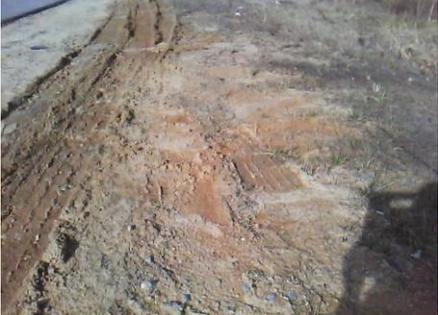
A29, A31
2	Turf	TF_84	Bareground

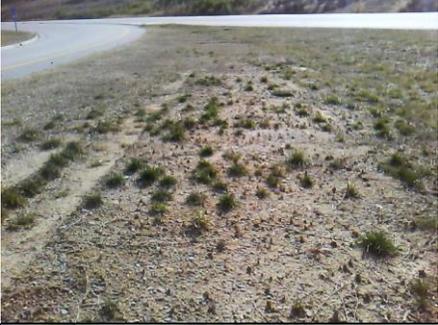
A30
3	Turf	TF_92	Bareground

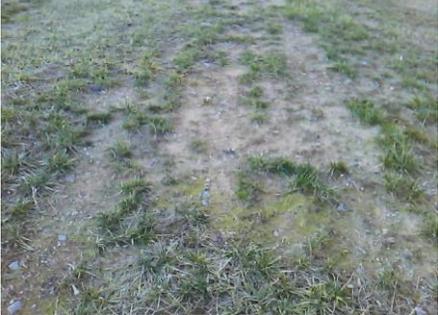
A30
4	Turf	TF_100	Bareground

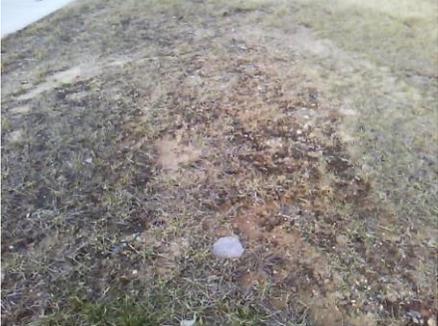
#	Material Type	Object ID	Failure Type	Photo	GIS Reference Page
5	Turf	TF_112	Bareground

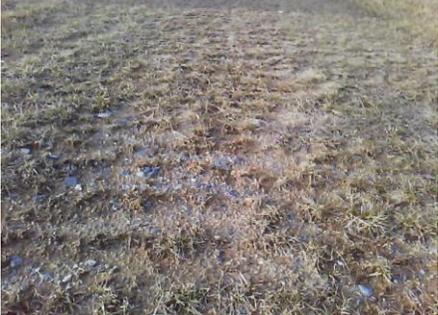
A33, A34
6	Turf	TF_118	Bareground

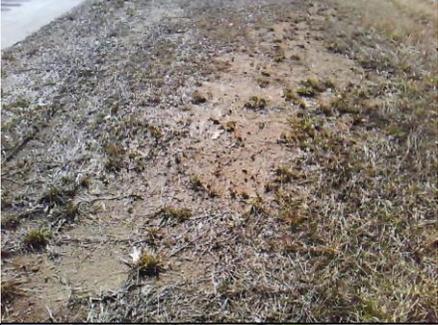
A36
7	Turf	TF_167	Bareground

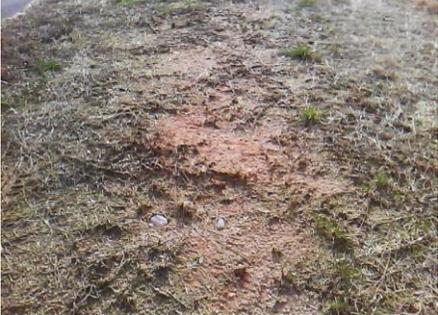
A32
8	Turf	TF_198	Bareground

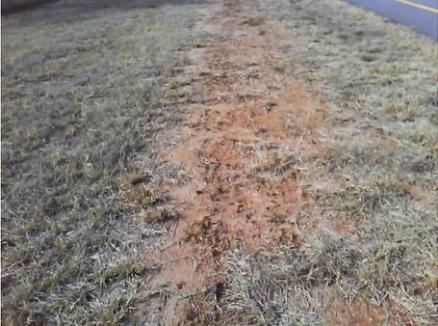
#	Material Type	Object ID	Failure Type	Photo	GIS Reference Page
9	Turf	TF_204	Bareground

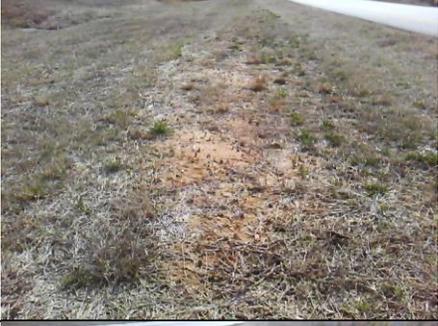
A29, A31
10	Turf	TF_207	Bareground

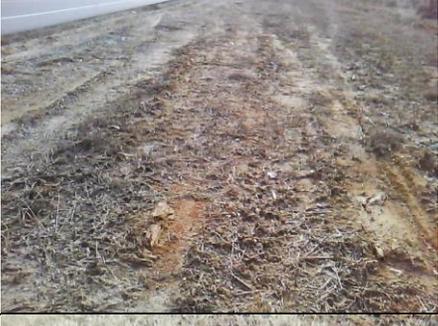
A29, A30, A31
11	Turf	TF_273	Bareground

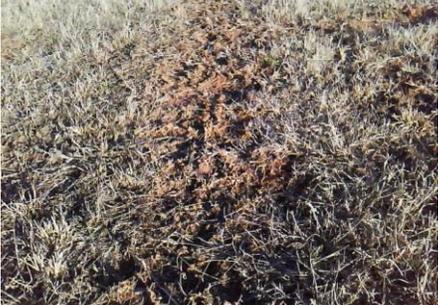
A38, A39
12	Turf	TF_324	Bareground

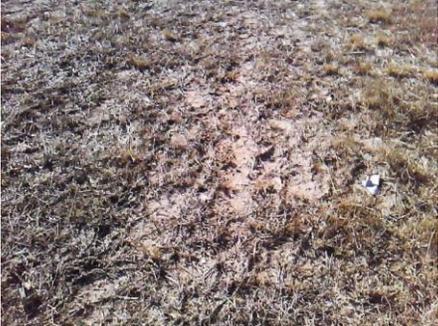
#	Material Type	Object ID	Failure Type	Photo	GIS Reference Page
13	Turf	TF_375	Bareground

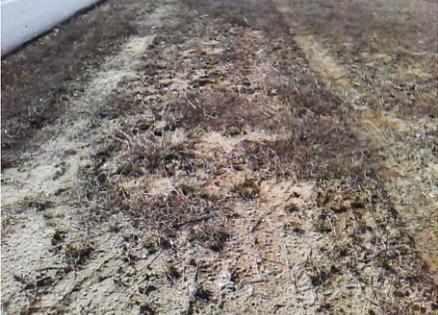
A43
14	Turf	TF_379	Bareground

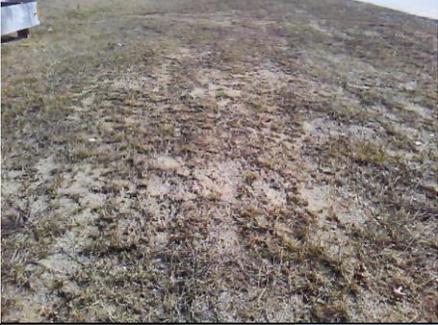
A41, A42
15	Turf	TF_410	Bareground

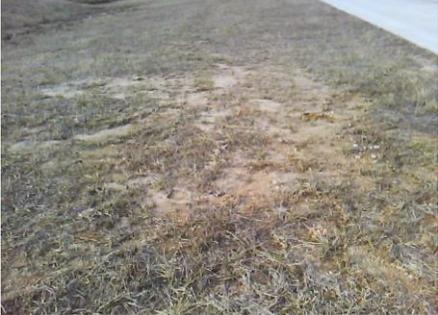
A38, A39
16	Turf	TF_447	Bareground

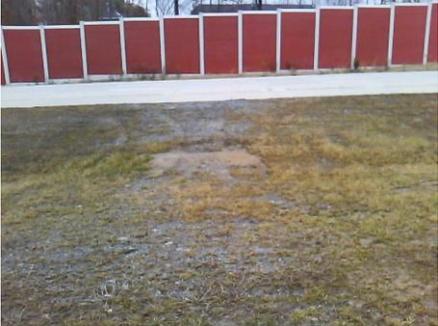
#	Material Type	Object ID	Failure Type	Photo	GIS Reference Page
17	Turf	TF_452	Bareground

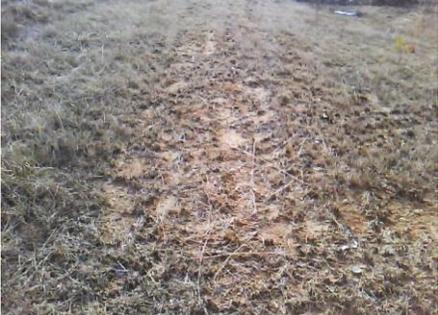
A35
18	Turf	TF_473	Bareground

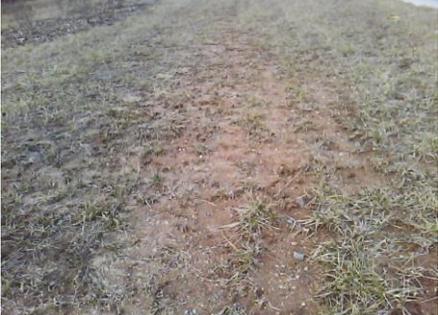
A38, A39
19	Turf	TF_487	Bareground

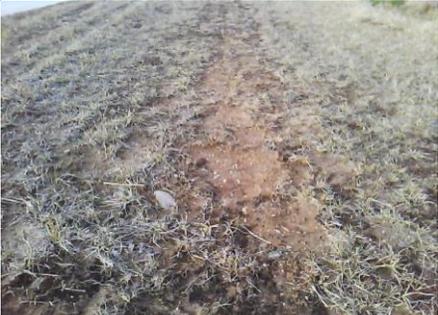
A33
20	Turf	TF_490	Bareground

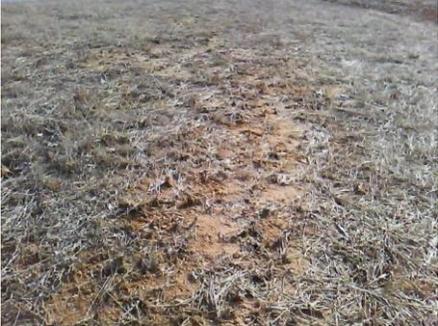
#	Material Type	Object ID	Failure Type	Photo	GIS Reference Page
21	Turf	TF_514	Bareground

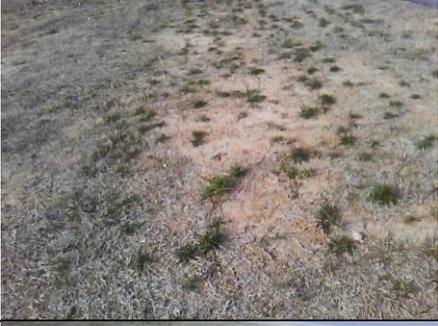
A31
22	Turf	TF_519	Bareground

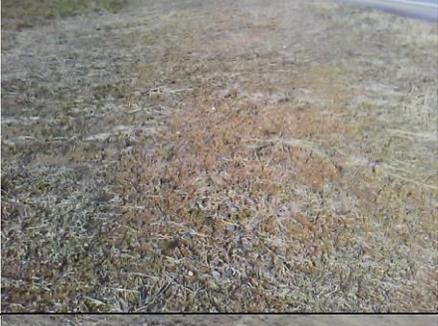
A29, A31
23	Turf	TF_525	Bareground

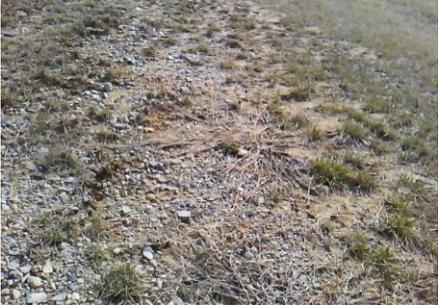
A30, A32
24	Turf	TF_529	Bareground

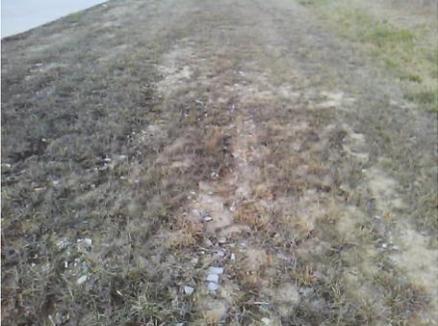
#	Material Type	Object ID	Failure Type	Photo	GIS Reference Page
25	Turf	TF_544	Bareground

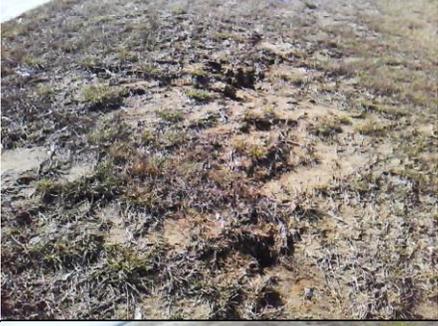
A28
26	Turf	TF_560	Bareground

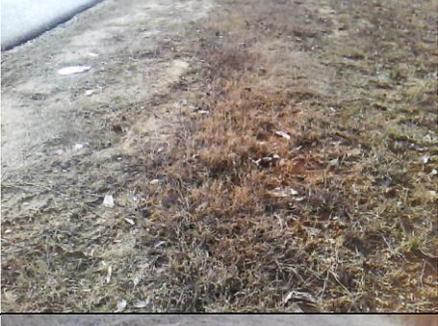
A26
27	Turf	TF_582	Bareground

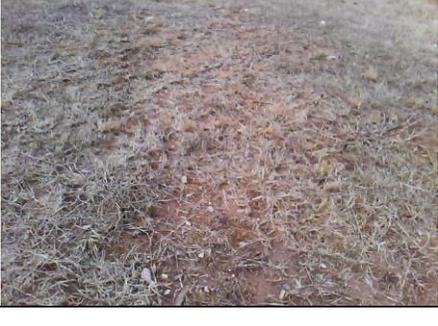
A23
28	Turf	TF_614	Bareground

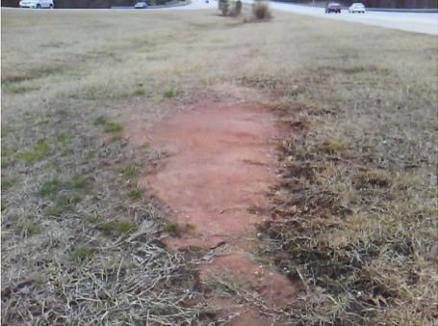
#	Material Type	Object ID	Failure Type	Photo	GIS Reference Page
29	Turf	TF_650	Bareground

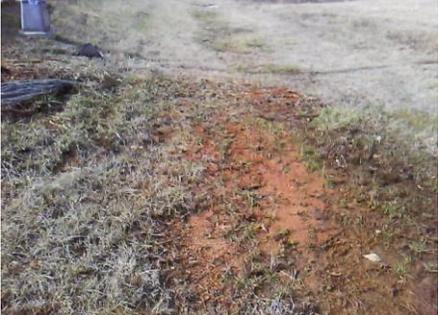
A14
30	Turf	TF_727	Bareground

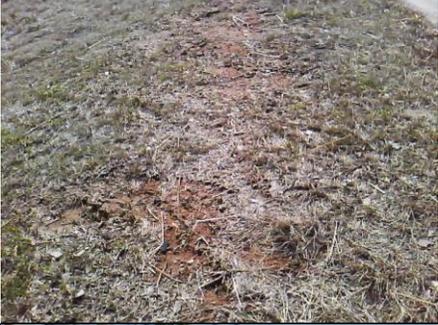
A7, A8
31	Turf	TF_736	Bareground

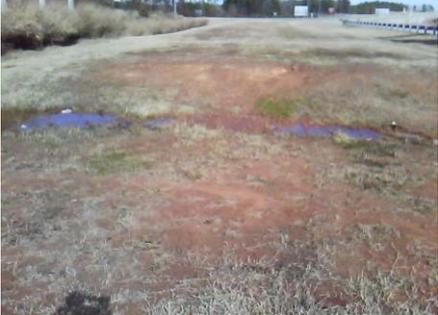
A6, A7
32	Turf	TF_785	Bareground

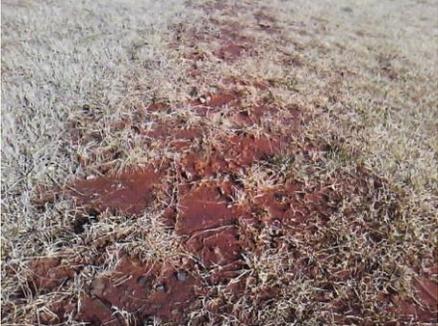
#	Material Type	Object ID	Failure Type	Photo	GIS Reference Page
33	Turf	TF_874	Bareground

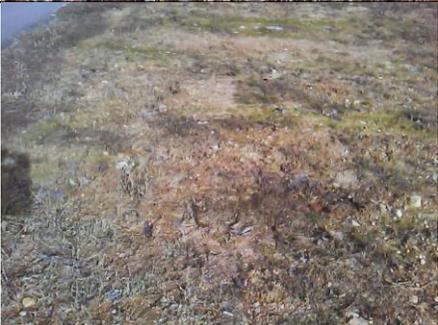
A56
34	Turf	TF_1004	Bareground

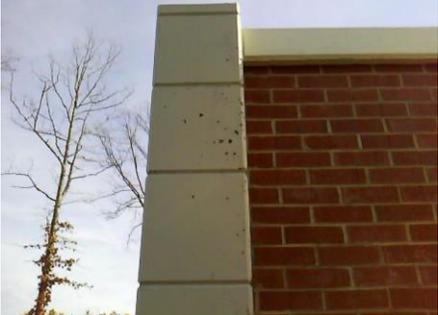
A7
2	Screen Wall	WL_31	Spalling

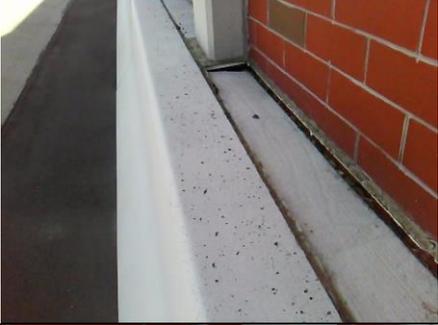
A54
3	Sound Wall	WL_49	Cracked Joint

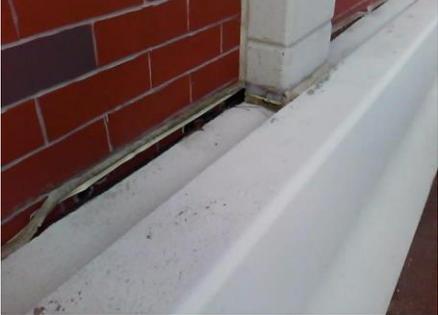
A35, A36
4	Sound Wall	WL_101	Cracked Joint
