NORTH CAROLINA
Turnpike Authority

Maintenance Rating Program

Triangle Expressway

2015 Second Quarter Report

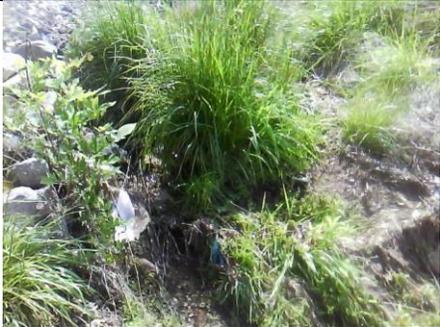
A5, A57
2	Drain	DP_381	Obstruction

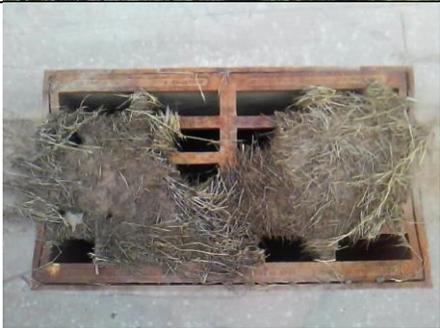
A8, A9
3	Lateral Pipe	DP_481	Obstruction

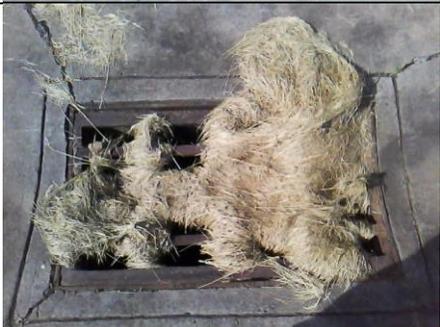
A55
4	Cross Pipe	DP_593	Obstruction

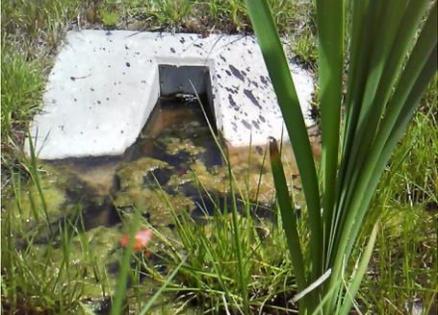
A53
2	Shoulder Drain	MDP_34	Obstruction

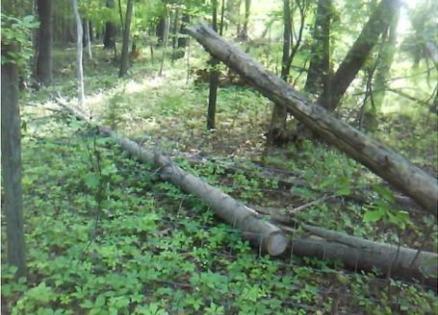
A5, A57
2	Woven	FN_238	Vegetation Compressing Fence

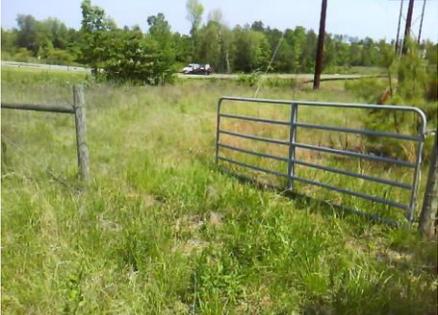
A56, A57
3	Woven	FN_259	Open Gate

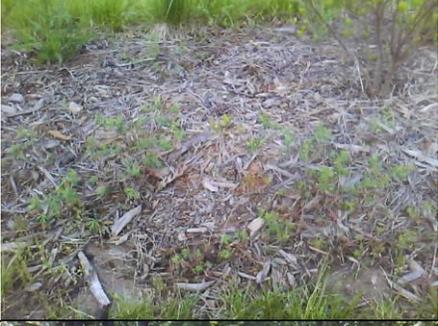
A53
2	Plant Bed	PB_72	Unwanted Weeds

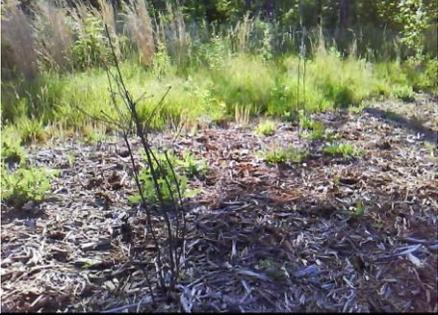
A54
3	Plant Bed	PB_80	Unhealthy Appearance

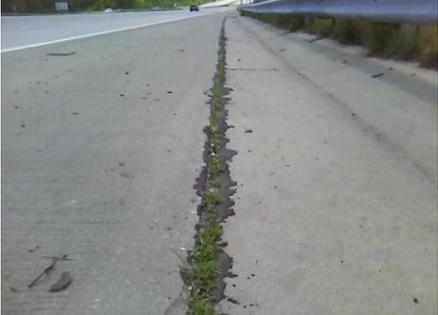
A6, A57
2	Concrete	LS_338	Paved Shoulder Joint

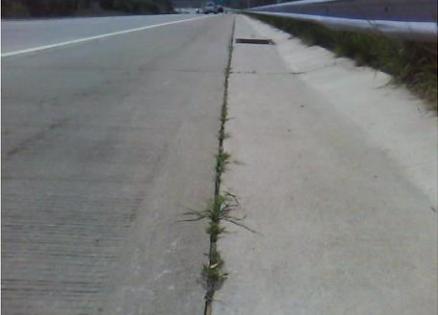
A9
3	Concrete	LS_355	Paved Shoulder Joint

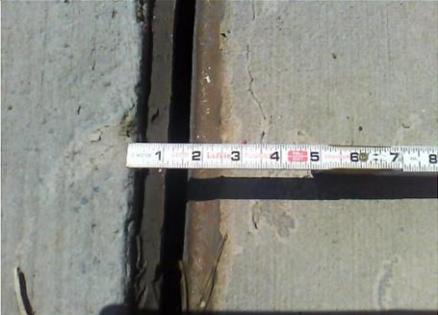
A4
4	Concrete	LS_493	Paved Shoulder Joint and Settlement

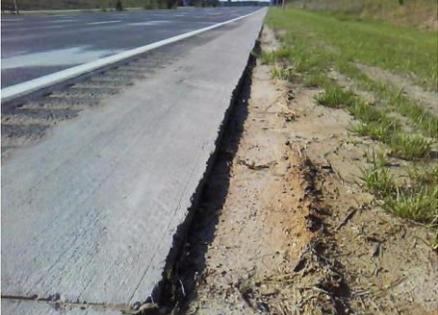
A photograph showing a close-up view of an asphalt road shoulder. The asphalt surface is on the left, and there is a sharp drop-off to a grassy area on the right. A white line is visible on the asphalt surface.	A49
2	Concrete	LS_405	Shoulder Dropoff

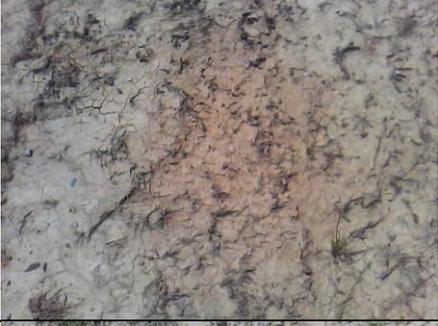
A12, A13
2	Turf	TF_42	Bareground

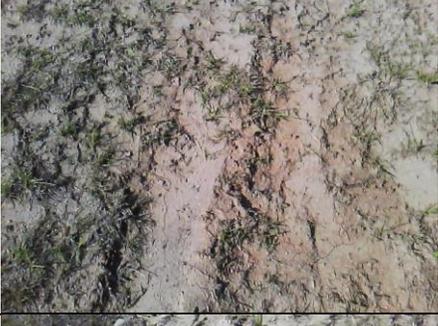
A22
3	Turf	TF_47	Bareground

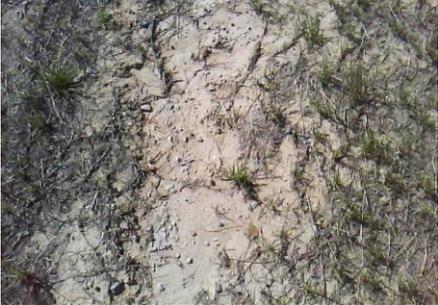
A13
4	Turf	TF_55	Bareground

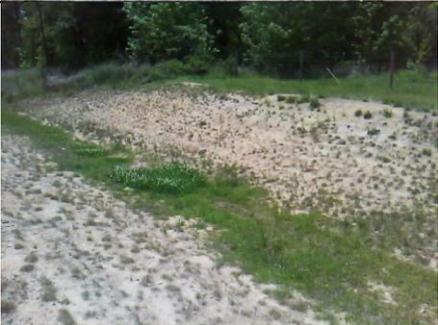
A29, A31
6	Turf	TF_108	Bareground

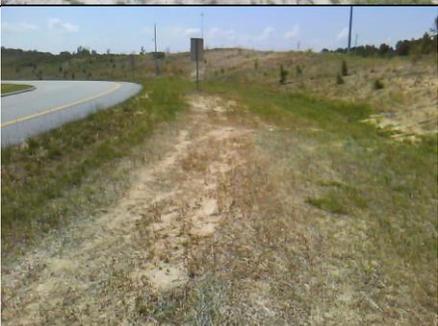
A29, A31
7	Turf	TF_144	Bareground

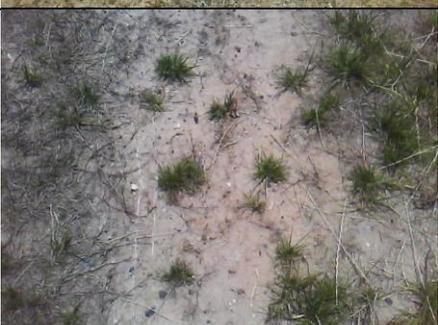
A41
8	Turf	TF_145	Bareground

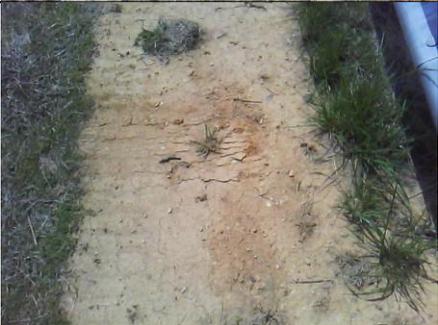
A43, A44
10	Turf	TF_172	Bareground

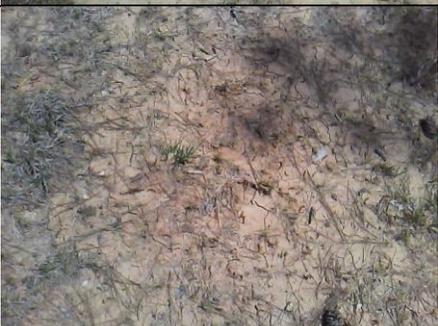
A40
11	Turf	TF_183	Bareground

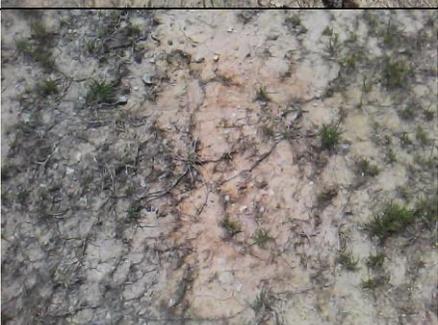
A37
12	Turf	TF_197	Bareground

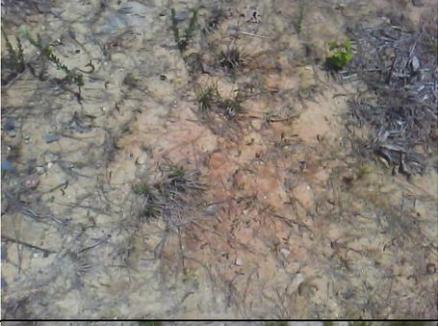
A29, A30, A31
14	Turf	TF_224	Bareground

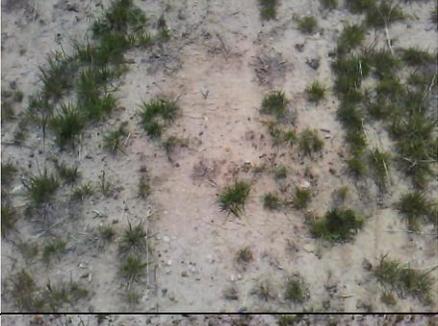
A29
15	Turf	TF_235	Bareground

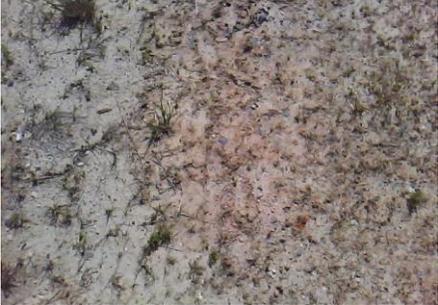
A40, A41
16	Turf	TF_236	Bareground

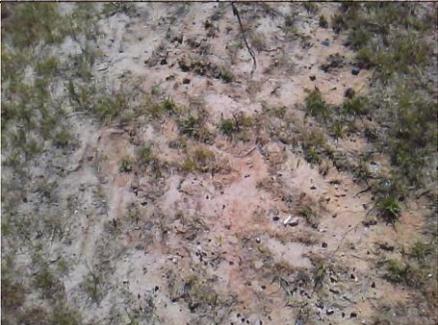
A53, A54
18	Turf	TF_325	Bareground

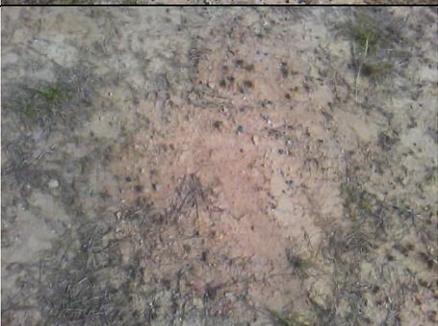
A44, A45
19	Turf	TF_397	Bareground

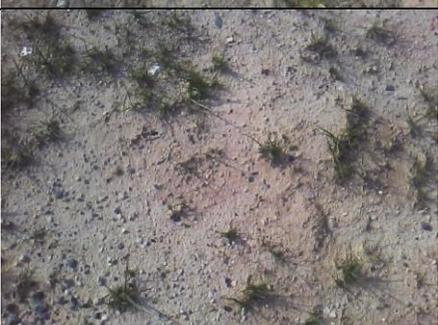
A39, A41
20	Turf	TF_431	Bareground

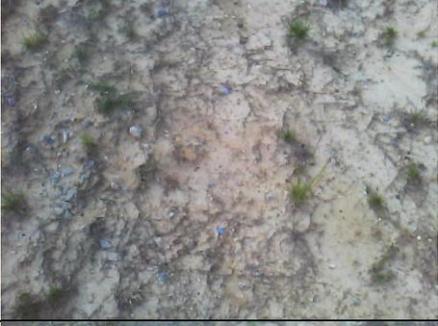
A31, A32
22	Turf	TF_520	Bareground

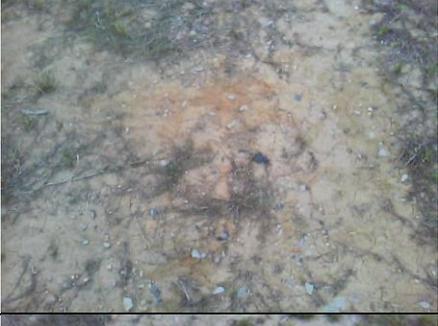
A28, A30
23	Turf	TF_548	Bareground

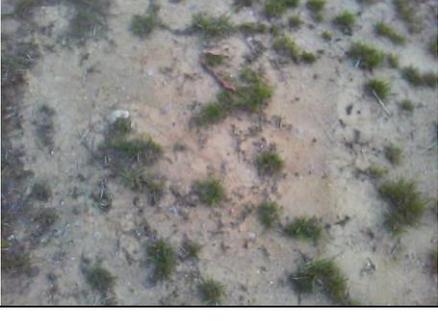
A26, A27
24	Turf	TF_556	Bareground

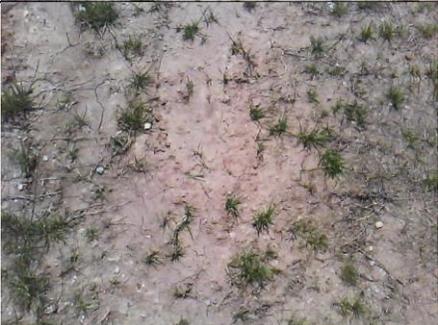
A23
26	Turf	TF_629	Bareground

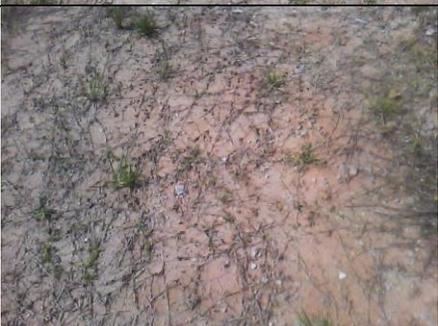
A17
27	Turf	TF_657	Bareground

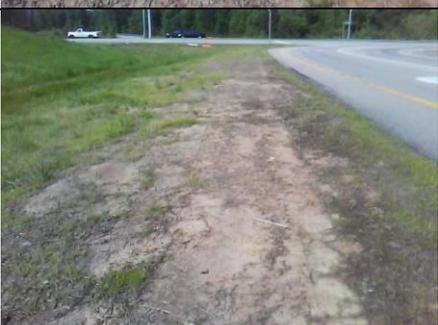
A13
28	Turf	TF_710	Bareground

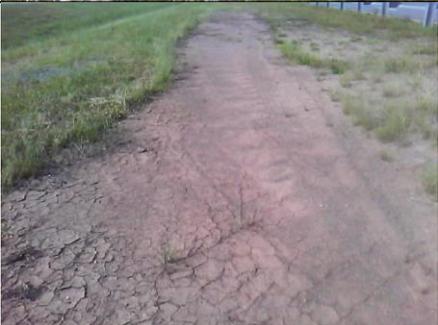
A8, A9
30	Turf	TF_748	Bareground

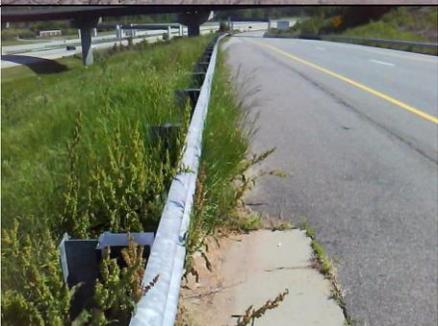
A6, A7
31	Turf	TF_777	Height

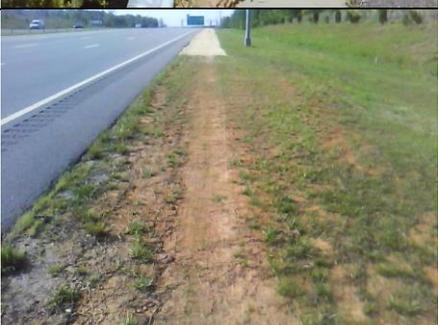
A5, A6
32	Turf	TF_857	Bareground

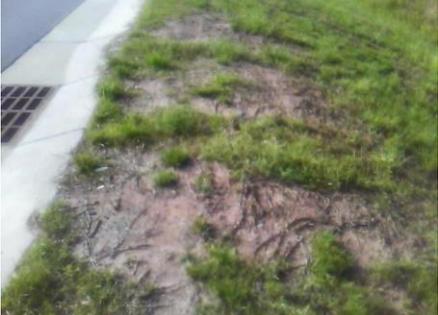
A53, A54
34	Turf	TF_914	Bareground

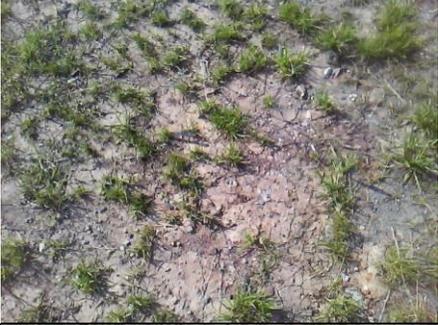
A51, A52
35	Turf	TF_934	Bareground

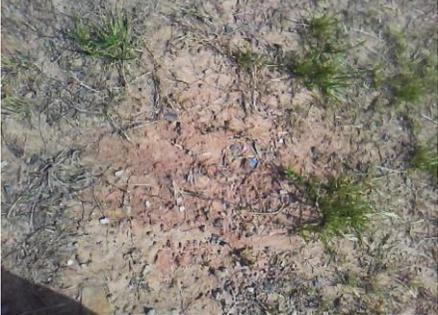
A53
36	Turf	TF_936	Bareground
